# **Service Bulletin**

Subject: Bulletin No: 01-007/14

UNUSUAL NOISE FROM EXHAUST PIPE SEAL RING

2009-2013 Mazda6 2.5L with automatic transmission

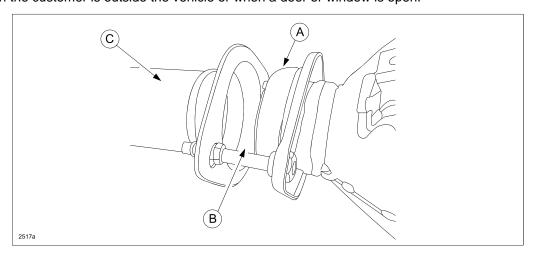
Due to engine vibration and a lack of seal ring lubrication, the mesh in the seal ring (A) rides in the flared portion (B) of the catalytic converter (C) resulting in a slight noise from the exhaust system while the engine is running. **The friction between the exhaust system parts and the resulting slight noise are normal.** This friction does not cause breakage, gas leakage, or other functional problems with the vehicle's exhaust system.

During normal vehicle aging, the noise level may change as the surface of the metal flange deteriorates. Usually this noise cannot be heard when the engine is running, however the noise may be heard in a quiet environment when the customer is outside the vehicle or when a door or window is open.

Customers having this concern should have their vehicle repaired using the following repair procedure.

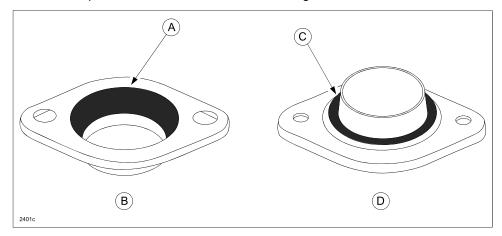
NOTE: Make sure the polished surface is free from seal ring residue, debris, or wear marks.

- 4. Remove the exhaust studs and washers (if any) and discard them.
- 5. Remove seal ring from exhaust manifold. Refer to the MS3 online instructions or Workshop Manual (section 01-15A EXHAUST SYSTEM REMOVAL/INSTALLATION [MZR 2.5]).
- 6. Stuff a cloth into exhaust manifold and catalytic converter to prevent dust or debris from entering.
- 7. Polish the flared portion (A) of catalytic converter-side (B) using a nylon brush or sandpaper (#60) for twenty (20) minutes, then use (#600) for three (3) minutes until bare metal is exposed.
- 8. Degrease (A) using ethanol for thirty (30) seconds.
- 9. Remove stains from the seal ring installed location (C) in exhaust manifold (D).
- 10. Degrease (C) using ethanol for thirty (30) seconds.

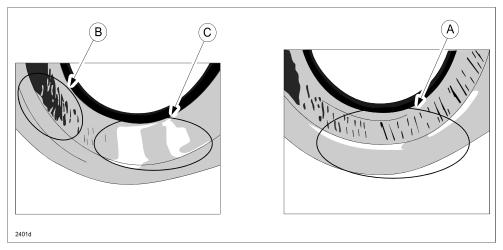
12. If severe damage appears on round surface of catalytic converter-side flared flange (A), replace catalytic converter.

NOTE: If the catalytic converter is replaced and a black coating (B) remains on the round surface of the flared flange, the white coating of the seal ring will stick to the black coating, which may cause noise. Be sure to sufficiently polish the flange (C).

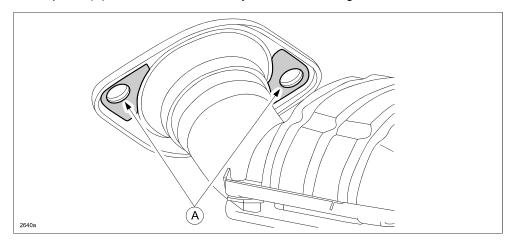
- In case where catalytic converter is NOT replaced:
  - a. Install a new exhaust stud.
  - b. Confirm if patch (A) exists behind the catalytic converter flange.

If YES (patch exists) - Install washer listed in the Part(s) Information to reduce spring tension. NEVER use an originally equipped washer.

If NO (patch does not exist) - Washer installation is NOT necessary.

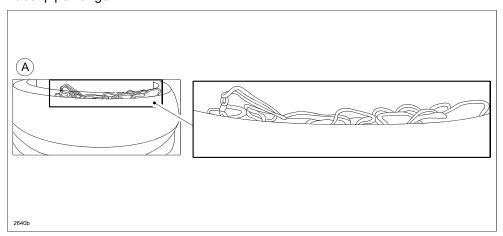
19. If the seal ring is NOT installed straight, mesh wire (A) will come out from the seal ring which will then contact the exhaust pipe flange.

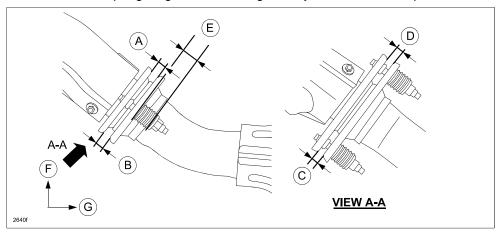
23. Measure the length and clearance between the flanges of the exhaust manifold and U/F catalytic converter. Verify that they are within the specification shown.

Α	Upper	9-12 mm
В	Lower	7-10 mm
С	Right	6-9 mm
D	Left	6-9 mm
E	Spring length (end-to-end)	29-31 mm
F	Vehicle upper	
G	Vehicle lower

**NOTE:** If the clearance or spring length is out of range, verify the cause and repair.
