© 2014 Mazda Motor of America, Inc.

<b>Subject:</b> <b>VARIOUS ELECTRICAL SYSTEM MALFUNCTION(S) RELATED TO C-15 CONNECTOR CORROSION</b>	<b>Bulletin No:</b> 09-005/14
	<b>Last Issued:</b> 03/14/2014

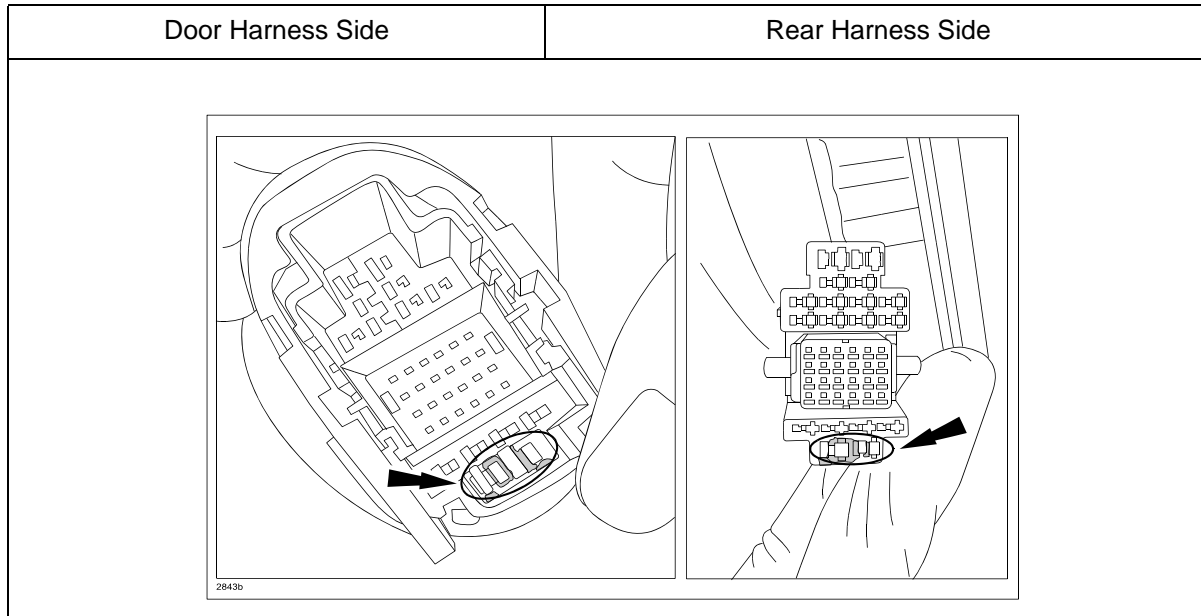
- If there is any corrosion at the C-15 connector, replace the door harness and repair the rear harness according to the following repair procedure.
  - If there is no corrosion found at the C-15 connector, this bulletin is not applicable. Troubleshoot the concern(s) according to the MS3 online instructions or the Workshop Manual.
1. Verify the customer concern.
  2. Record customers pre-set radio stations.
  3. Slide the driver side front seat fully backwards.
  4. Disconnect the negative battery cable.
  5. Disconnect the C-15 connector according to the MS3 online instructions or the Workshop Manual (section 09-11 FRONT DOOR REMOVAL/INSTALLATION).
  6. Inspect for any corrosion found on the terminals shown below.

- If there is any corrosion found on the terminals, go to next step.
- If there is no corrosion found on the terminals, this bulletin is not applicable. Troubleshoot the concern(s) according to the MS3 online instructions or the Workshop Manual.
