Subject: RATTLE NOISE FROM FRONT DOOR GLASS	Bulletin No: 09-017/14
	Last Issued: 03/05/2014

2013-2014 CX-5 vehicles with VINs lower than JM3KE*****433172 (produced before January 13, 2014)

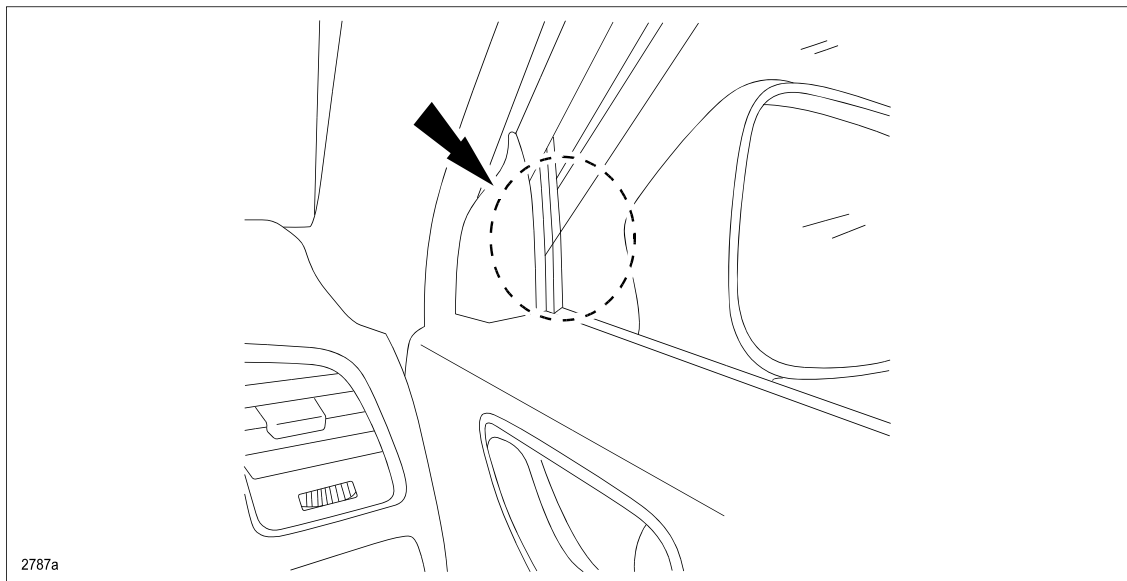
Some vehicles may experience a rattle noise from the front door glass when driving with the window open approx. 1/2 to 4 inches (1 - 10 cm).

The rattle noise may be caused by insufficient glass run channel holding force. To eliminate this concern, the shape of glass run channel has been changed in order to increase the holding force.
