| Subject: CRACKING NOISE FROM WINDSHIELD (SD AND HB) AND/OR REAR WINDOW (SD ONLY) | Bulletin No: 09-025/14 Last Issued: 05/29/2014 |

2010-2012 Mazda3 (including Mazdaspeed3)

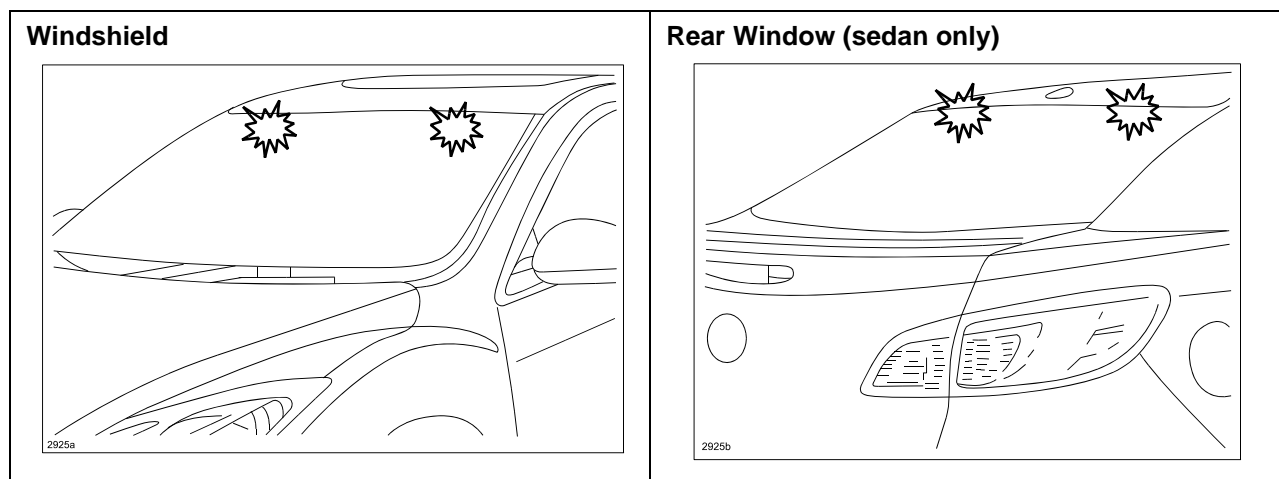
Some vehicles may exhibit a cracking noise originated at the positioning pins near the top corners of the windshield and/or rear window when driving on uneven road surface. This happens when the ambient temperature is approximately 14 °F (-10 °C) or lower and the vehicle cabin has not yet warmed up. The noise is caused by the windshield and/or rear window locating stopper contacting the panel.

1. Verify customer concern.
2. Cut the end of the stopper and bend the panel at the affected windshield and/or rear window.
