<b>Subject:</b> <b>MULTIPLE ELECTRICAL MALFUNCTIONS AFTER BODY REPAIR</b>	<b>Bulletin No:</b> 09-022/14
	<b>Last Issued:</b> 05/20/2014

- 2013-2014 CX-5
- 2014 Mazda3
- 2014-2015 Mazda6

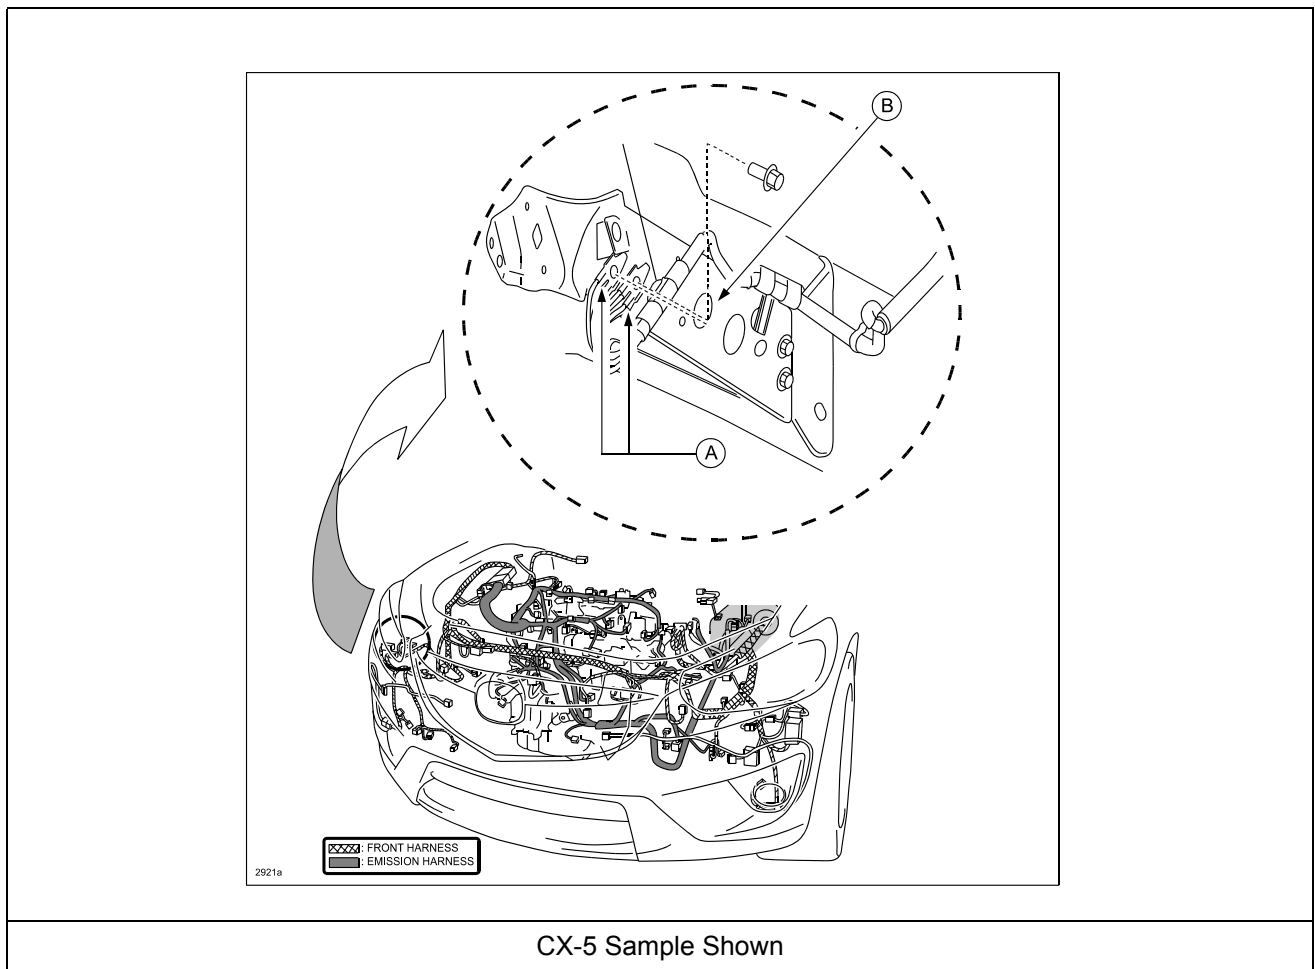
Some customers may experience an electrical malfunction after a vehicle body repair. The newly painted fender stay (B) may be causing a poor front harness (A) ground connection.

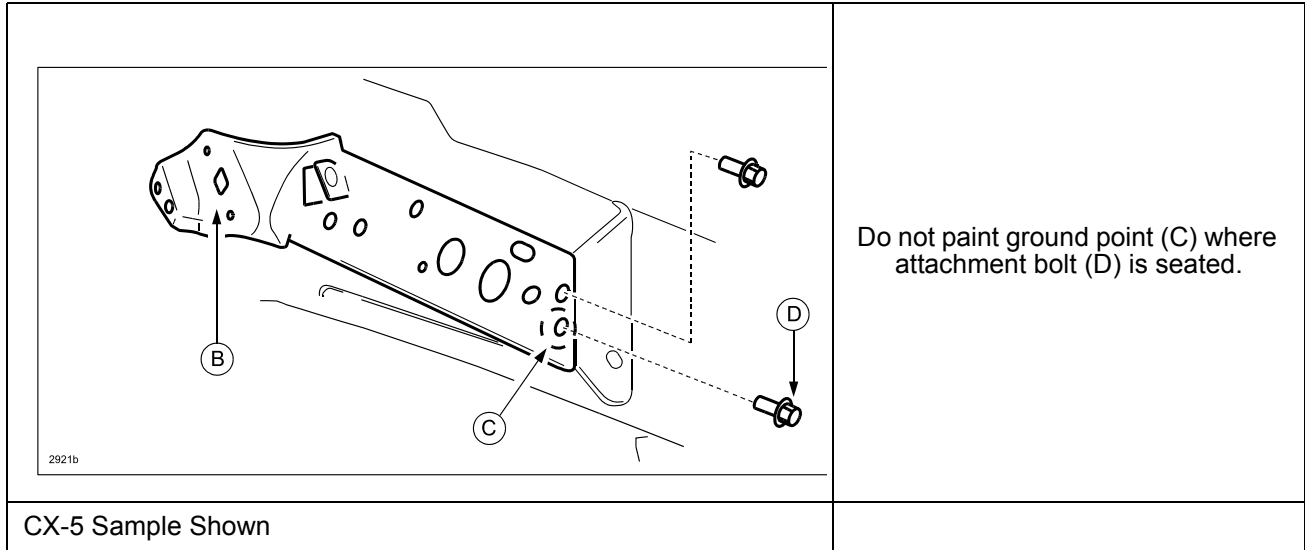
The front fender stay (B) newly painted surface at ground point (C), where attachment bolt (D) is seated, may create a poor front harness ground connection.

Customer concern can be resolved by sanding off paint at ground point (C) where attachment bolt (D) is seated. After installing the bolt (D), apply touch-up paint to the exposed base material area of the front fender stay.

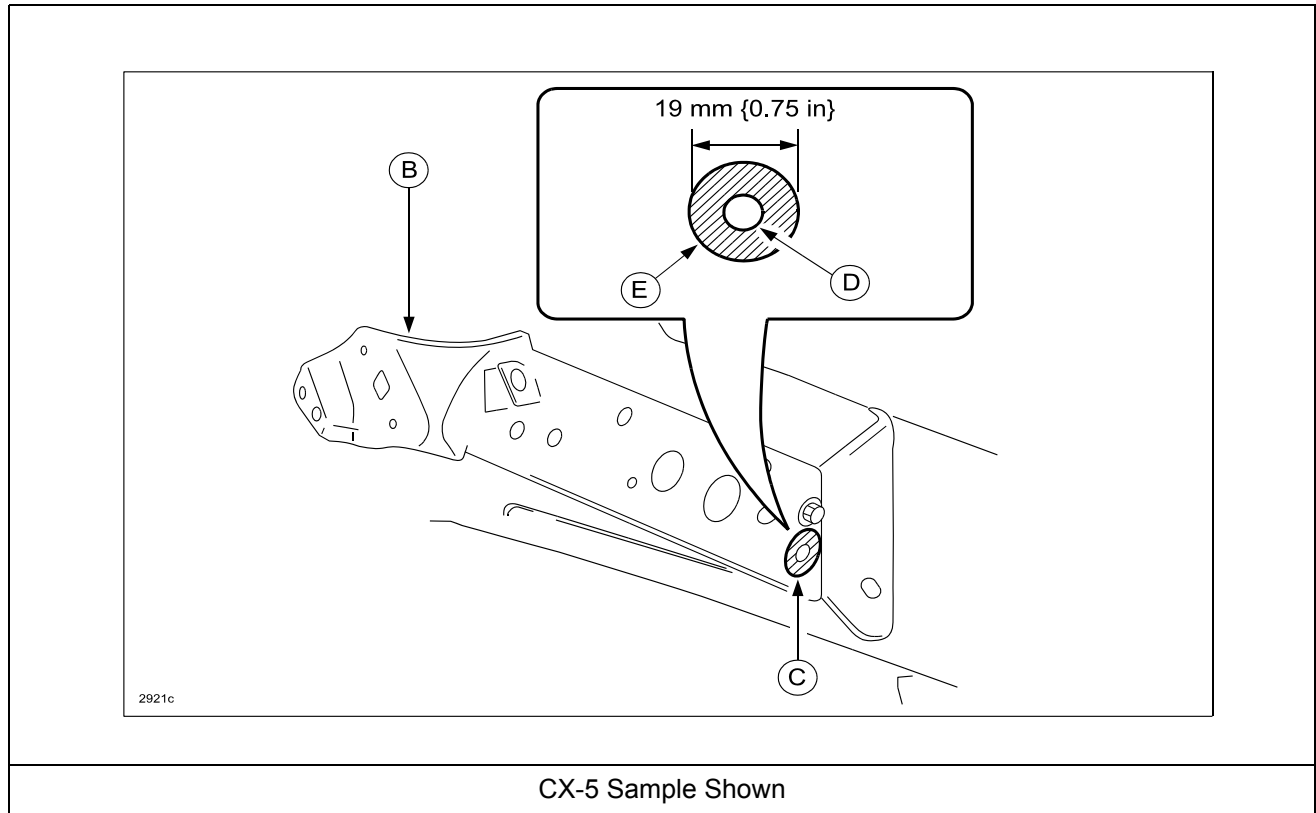
**CAUTION:** If the bolt (D) contact area (C) is painted when the front fender stay (B) is newly replaced, it could cause a malfunction in the PCM. Before painting a newly replaced part, protect the bolt (D) contact area (C) with masking tape (E) as shown in the figure.

**NOTE:** After installing the bolt (D), apply touch-up paint to the exposed base material area of the front fender stay.
