**Subject:**

**RATTLE / CHATTER NOISE FROM REAR DIFFERENTIAL**

**Bulletin No:** 03-002/14

2013-2014 CX-5 vehicles with VINs lower than JM3 KE \*\*\*\*\* 391989 (produced before September 16, 2013)

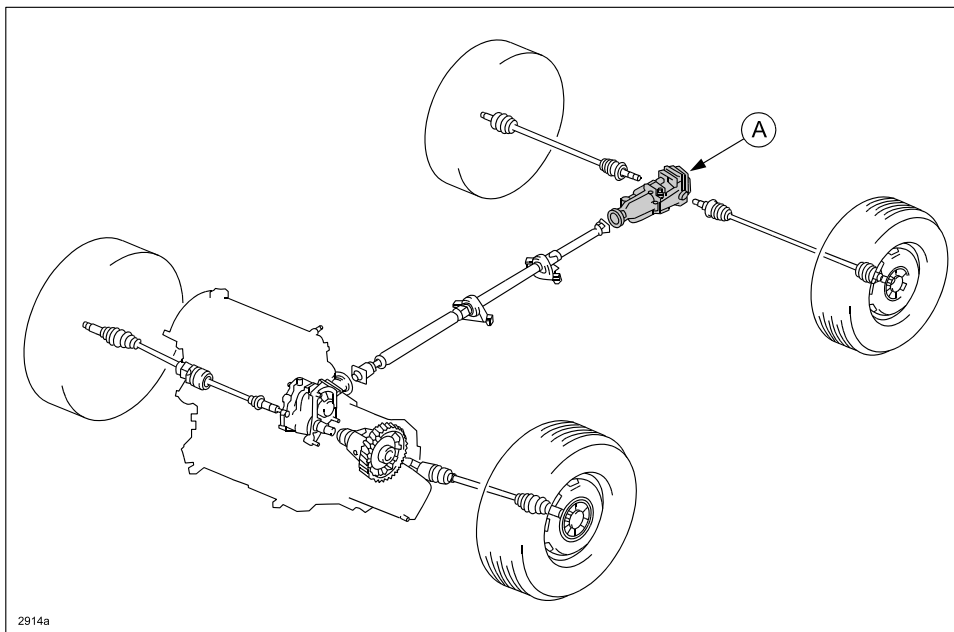
While driving at low speeds, some vehicles may exhibit a chattering/rattling type noise from the rear of the vehicle. A rear differential component, internal bearing noise, may be the cause.

1. Lift the vehicle. Refer to MS3 online (section 00-00 JACKING POSITIONS, VEHICLE LIFT (2 SUPPORTS) AND SAFETY STAND (RIGID RACK) POSITIONS).
2. Verify if the noise is heard from the rear differential component (A) when the wheel speed is approximately 3 to 6 mph (5 to 10 km/h).

3. Has the noise been verified?
  - a. Yes - Proceed to step 4.
  - b. No - This bulletin does not apply. Refer to MS3 online or Workshop Manual (section 03-03 NO.3 ABNORMAL NOISE AND/OR VIBRATION FROM COUPLING COMPONENT).
4. Contact MASH at 888 832-8477, option 2, to obtain authorization to replace the rear differential component (including the coupling unit). Refer to MS3 online or Workshop Manual (section 03-14 REAR DIFFERENTIAL REMOVAL/INSTALLATION).

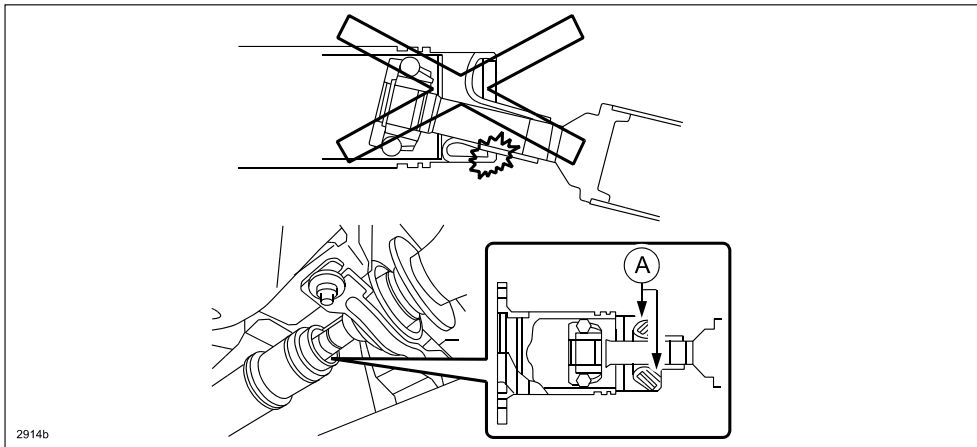
2914b

**CAUTION:** If the constant velocity joint angle is excessive during propeller shaft removal/installation, the constant velocity joint boot may be damaged when contacting the metallic cover. Protect the constant velocity joint boot by inserting a shop rag (A) between the boot and the metallic cover.
