Subject: VARIOUS ELECTRICAL SYSTEM MALFUNCTION(S) RELATED TO C-15 CONNECTOR CORROSION	Bulletin No: 09-005/14
	Last Issued: 05/08/2014

2013-2014 CX-5 vehicles with VINs lower than JM3KE*****365953 (produced before June 25, 2013)

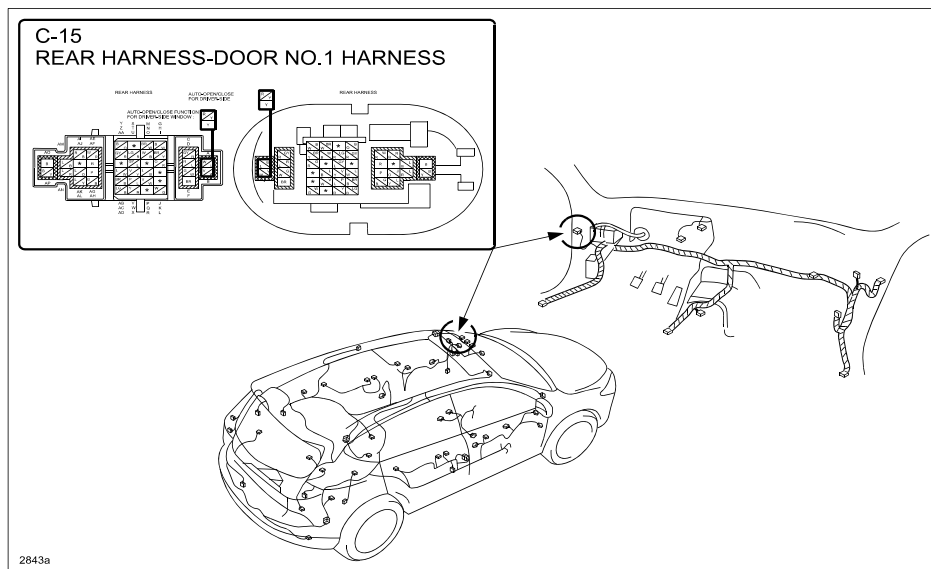
The symptoms listed above may be caused by corrosion of the C-15 connector terminals due to water intrusion through the front door. In low ambient temperatures, the door harness hardens. If the door is fully opened, it may create a gap between the door and the door harness grommet, which may allow water to enter through the gap.

- The front door harness grommet has been changed to improve sealing performance.
- Holes inside the front pillar (which are made for weight reduction), have been covered to prevent water intrusion.

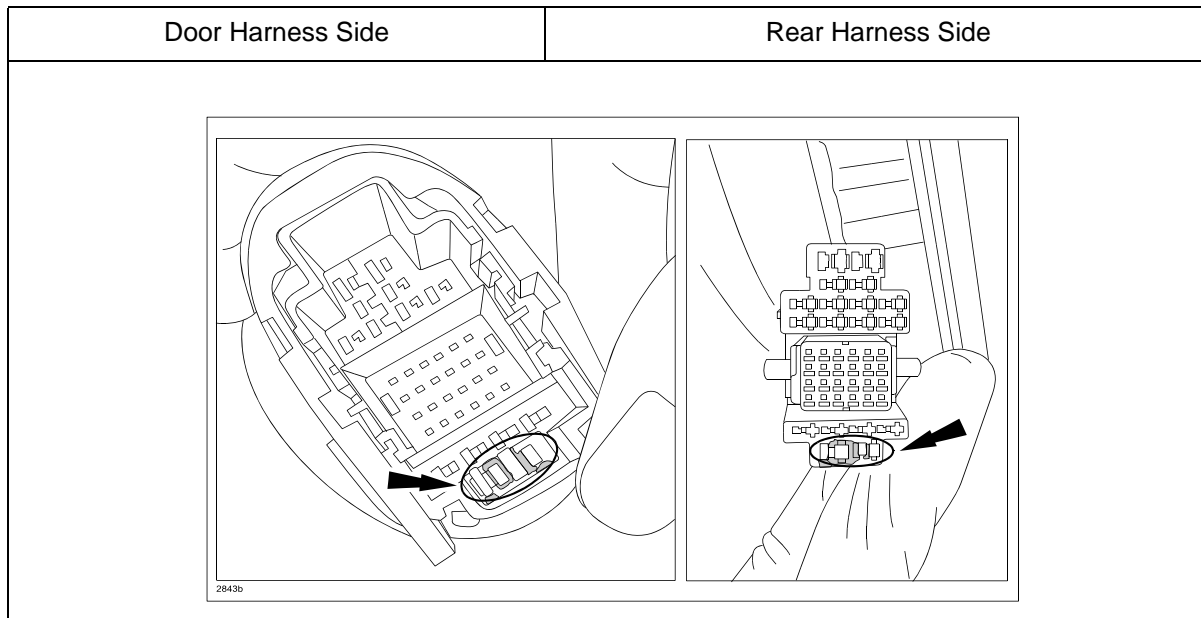
- If there is any corrosion at the C-15 connector, replace the door harness and repair the rear harness according to the following repair procedure.
 - If there is no corrosion found at the C-15 connector, this bulletin is not applicable. Troubleshoot the concern(s) according to the MS3 online instructions or the Workshop Manual.
1. Verify the customer concern.
 2. Record customers pre-set radio stations.
 3. Slide the driver side front seat fully backwards.
 4. Disconnect the negative battery cable.
 5. Disconnect the C-15 connector according to the MS3 online instructions or the Workshop Manual (section 09-11 FRONT DOOR REMOVAL/INSTALLATION).
 6. Inspect for any corrosion found on the terminals shown below.

- If there is any corrosion found on the terminals, go to next step.
- If there is no corrosion found on the terminals, this bulletin is not applicable. Troubleshoot the concern(s) according to the MS3 online instructions or the Workshop Manual.
