Subject: MASTER WARNING LIGHT IS ON AND INSTRUMENT CLUSTER WARNING MESSAGE IS DISPLAYED (DTC P1794 or DTC P1794 and P2502)	Bulletin No: 01-001/14 Last Issued: 05/06/2014
---------------------------------------------------------------------------------------------------------------------------------------------	-----------------------------------------------------------------

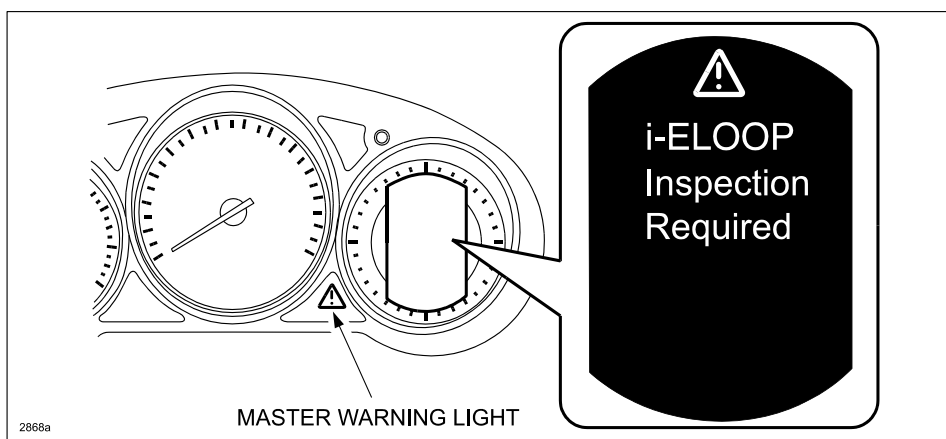
- Warning message “i-ELOOP Inspection Required” is displayed in the instrument cluster information display while driving.
- The Master warning light will be illuminated.

- DTC P1794:00 (Capacitor (i-ELOOP) system: Capacitor (i-ELOOP) malfunction) will be stored in PCM memory.

Customers having this concern should have their vehicle repaired using A. REPAIR PROCEDURE.
