<b>Subject:</b>  <b>OIL SEEPAGE FROM JOINT SHAFT</b>	<b>Bulletin No:</b> 03-001/14
	<b>Last Issued:</b> 05/05/2014

2010-2013 Mazda3

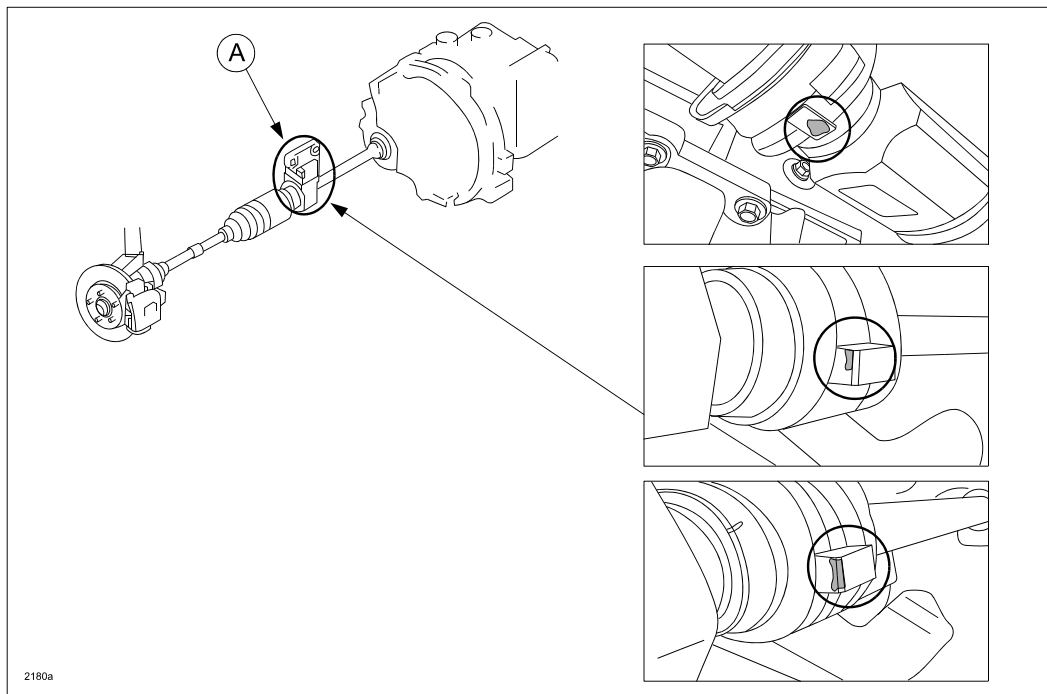
Some new vehicles may exhibit oil seepage underneath the bearing bracket (A) on the right side of the joint shaft. This is caused by the oil content separating from the grease applied to the bearing and spline seeping from the seal and bracket.

There is no functional problem with this issue since the amount of oil seepage is very small compared to the amount of grease. Note that the oil seepage will stop while the vehicle is in use.

If you encounter a customer complaint about this concern, wipe off the oil with a rag. DO NOT replace the joint shaft.
