Service Bulletin

Subject: CHECK ENGINE LIGHT ON WITH DTC P0191:00 OR P0192:00	Bulletin No:	01-010/14
	Last Issued:	04/29/2014

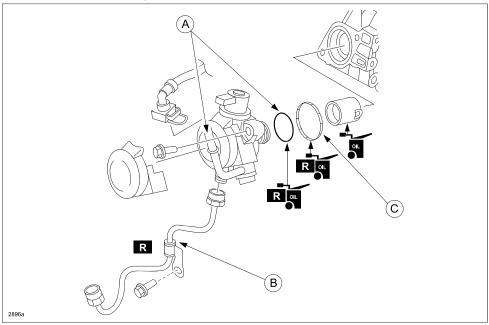
This is caused by the high pressure fuel pump not generating the target fuel pressure (due to a manufacturing error of the inner parts). To correct the problem, production control has been improved.

- 1. Verify customer concern.
- 2. Replace the high pressure fuel pump with a modified one according to the Workshop Manual.
- 3. Replace the high pressure fuel pump (A: fuel pump; B: fuel pipe; C: rubber seal) with a modified one according to the instructions on MS3 online or the Workshop Manual (section 01-14 HIGH PRESSURE FUEL PUMP REMOVAL/INSTALLATION).
