Subject: CLUNKING NOISE FROM NO. 3 ENGINE MOUNT	Bulletin No: 01-011/14
	Last Issued: 04/15/2014

2007-2012 CX-7

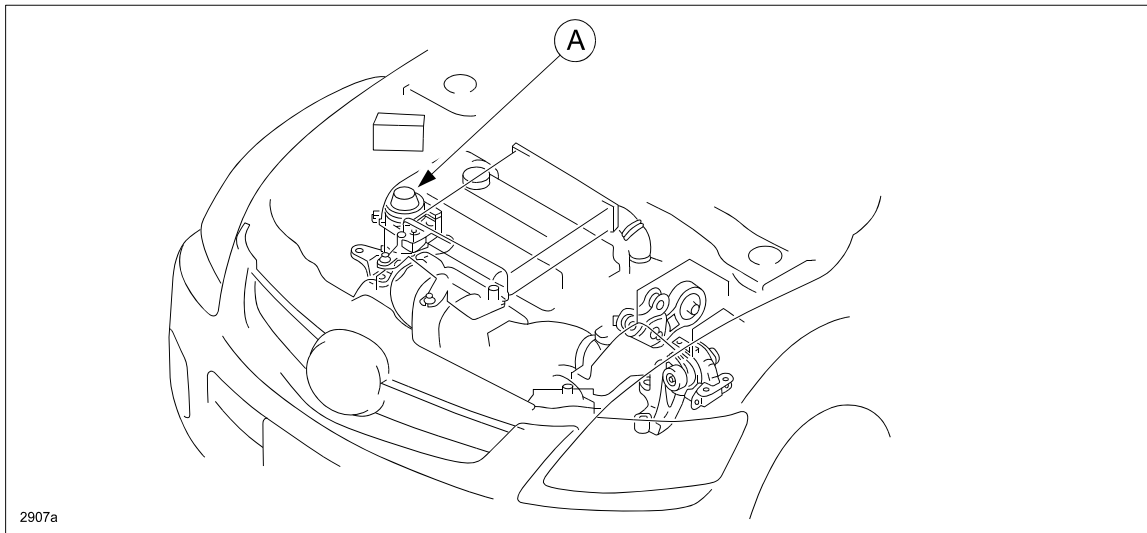
Some vehicles may exhibit a clunk noise from the engine compartment when driving over rough roads or over a speed bump. The noise may occur in areas of high ambient temperatures.

Due to high heat, the lubricant inside the No. 3 engine mount rubber (A) may become ineffective, causing a stick-slip noise between the casing and the rubber, however, there is no seepage from the engine mount.

The engine mount rubber uses a new type of lubricant to eliminate this concern.

1. Verify the customer concern.
2. Replace the No. 3 engine mount according to the instructions on MS3 online or the Workshop Manual: (CX-7 2.3L (L3 Turbo) Engine, section 01-10 NO. 3 ENGINE MOUNT DISASSEMBLY/ASSEMBLY) or (CX-7 2.5L (L5) Engine, section 01-10 NO. 3 ENGINE MOUNT DISASSEMBLY/ASSEMBLY).
3. Verify the repair.
