Service Bulletin

Subject:
 Bulletin No:
 01-010/14

MIL ON WITH DTC P0191:00
 Last Issued:
 04/07/2014

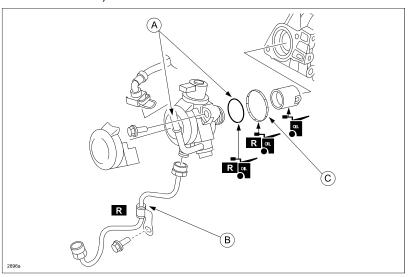
Some vehicles may experience the MIL on with DTC P0191:00 (Fuel pressure sensor circuit range/performance problem) stored in memory. This is caused by the high pressure fuel pump not generating the target fuel pressure (due to a manufacturing error of the inner parts). To correct the problem, production control has been improved.

- 1. Verify customer concern.
- 2. Replace the high pressure fuel pump with a modified one according to the Workshop Manual.
- Replace the high pressure fuel pump (A: fuel pump; B: fuel pipe; C: rubber seal) with a modified one according to the instructions on MS3 online or the Workshop Manual (section 01-14 HIGH PRESSURE FUEL PUMP REMOVAL/INSTALLATION).
