Service Bulletin

Bulletin No:	01-007/14
Last Issued:	04/03/2014

2009-2013 Mazda6 2.5L with automatic transmission

DESCRIPTION

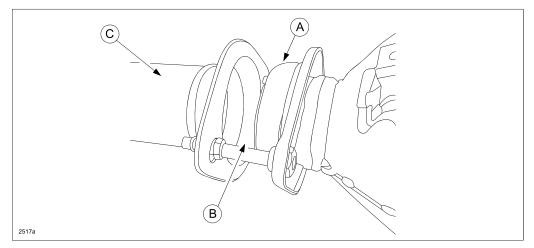
Due to engine vibration and a lack of seal ring lubrication, the mesh in the seal ring (A) rides in the flared portion (B) of the catalytic converter (C) resulting in a slight noise from the exhaust system while the engine is running. **The friction between the exhaust system parts and the resulting slight noise are normal.** This friction does not cause breakage, gas leakage, or other functional problems with the vehicle's exhaust system.

During normal vehicle aging, the noise level may change as the surface of the metal flange deteriorates. Usually this noise cannot be heard when the engine is running, however the noise may be heard in a quiet environment when the customer is outside the vehicle or when a door or window is open.

Customers having this concern should have their vehicle repaired using the following repair procedure.

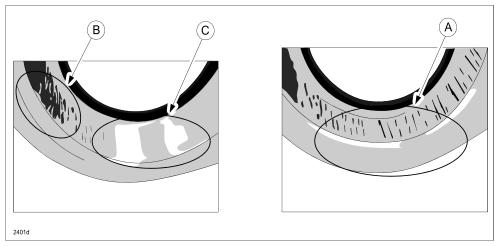
- 12. If severe damage appears on round surface of catalytic converter-side flared flange (A), replace catalytic converter.
 - NOTE: If the catalytic converter is replaced and a black coating (B) remains on the round surface of the flared flange, the white coating of the seal ring will stick to the black coating, which may cause noise. Be sure to sufficiently polish the flange (C).

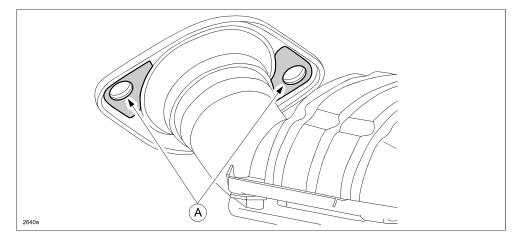
- In case where catalytic converter is NOT replaced:
 - a. Install a new exhaust stud.
 - b. Confirm if patch (A) exists behind the catalytic converter flange.

If YES (patch exists) - Install washer listed in the Part(s) Information to reduce spring tension. NEVER use an originally equipped washer.

- If NO (patch does not exist) Washer installation is NOT necessary.
- In case where catalytic converter is replaced:
 - a. Install a new exhaust stud.
 - b. Washer installation is NOT necessary (as no patch exists on new catalytic converter listed in the Part(s) Information.
- 13. Using a piece of cloth including organic solvent (acetone, methanol) or a piece of cloth free of oil content, wipe off any debris or grease from polished area.

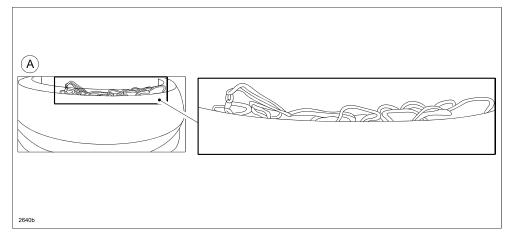
19. If the seal ring is NOT installed straight, mesh wire (A) will come out from the seal ring which will then contact the exhaust pipe flange.

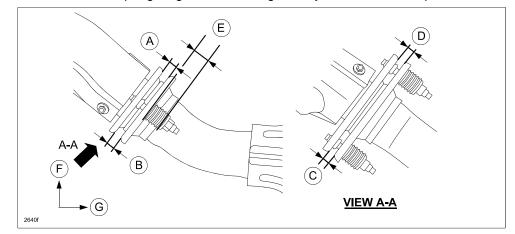
A	Upper	9-12 mm
В	Lower	7-10 mm
С	Right	6-9 mm
D	Left	6-9 mm
E	Spring length (end-to-end)	29-31 mm
F	Vehicle upper	
G	Vehicle lower

23. Measure the length and clearance between the flanges of the exhaust manifold and U/F catalytic converter. Verify that they are within the specification shown.

NOTE: If the clearance or spring length is out of range, verify the cause and repair.
