Subject: HOOD VIBRATION WHILE DRIVING AT HIGHWAY SPEED	Bulletin No: 09-028/14
	Last Issued: 06/27/2014

2013-2014 CX-5 vehicles with VINs lower than JM3KE*****387092 (produced before September 1, 2013)

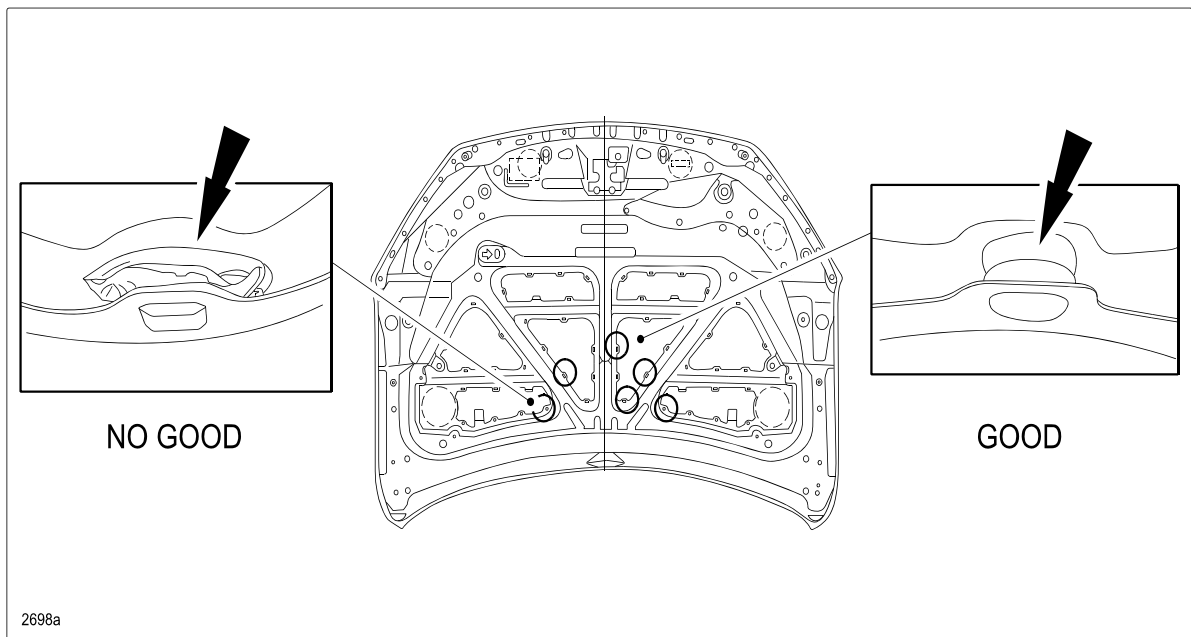
The amount of sealant used to fill in the space between the inner frame and outer panel at the bottom area of the hood is insufficient. If the sealant detaches (as shown below on the left), it may cause the hood to vibrate. The amount of sealant has been increased during vehicle production and the preload force of the cowl grill seal has been increased to eliminate the concern.

The cowl grill seal will be replaced with a modified part, additional dampening material may be applied between the hood's inner frame and outer panel and the hood height may be adjusted to apply additional tension.
