Subject: DRIVER-SIDE POWER DOOR MIRROR VIBRATION	Bulletin No: 09-026/14
	Last Issued: 06/10/2014

2013-2015 CX-5 vehicles with VINs lower than JM3KE*****465579 (produced before April 1, 2014)

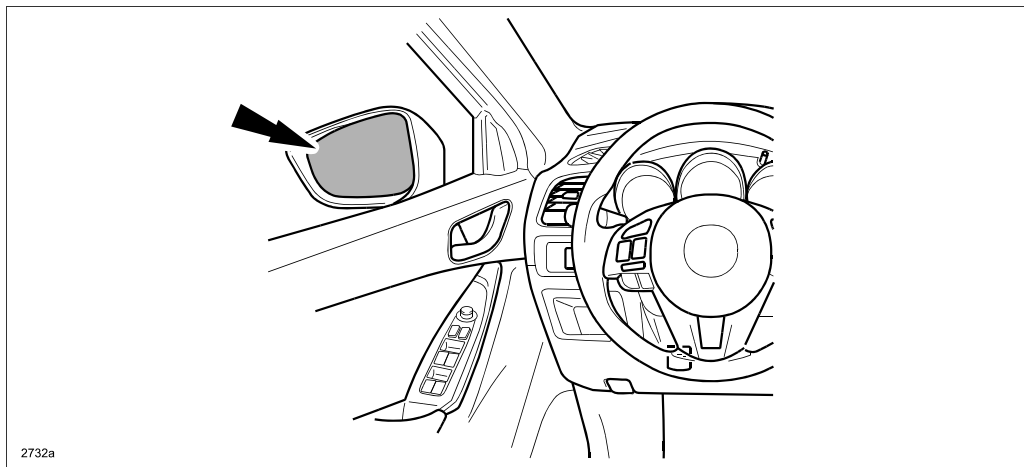
Some vehicles may exhibit a vibration from the driver-side power door mirror glass when the vehicle is driven at high speeds.

This concern may be due to a lack of rigidity of the mirror base so the mirror vibrates when it receives vehicle vibration or wind pressure.

An additional reinforcement has been installed inside the door to increase the door panel strength where the door mirror is mounted. Also, the door mirror shape has been changed. Both of these modifications have been implemented to eliminate mirror glass vibration concerns.
