© 2014 Mazda Motor of America, Inc.

Subject: INFORMATION DISPLAY SHOWS "FOW INSPECTION REQUIRED" AND DTC C1A67:78 IS STORED	Bulletin No: 01-016/14
	Last Issued: 07/24/2014

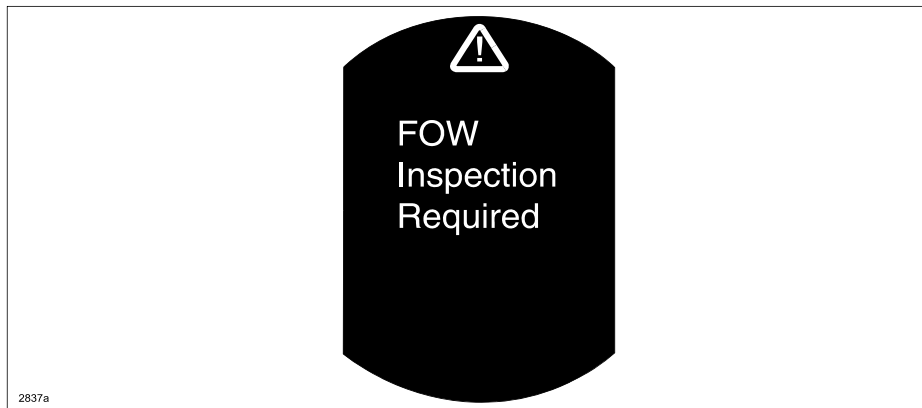
Some customers may experience a MRCC malfunction when driving long distances with MRCC set. Instrument cluster information display shows "FOW INSPECTION REQUIRED" and DTC C1A67:78 (Radar sensor axis is deviated) is stored. This is caused by MRCC no obstacle detection during a long drive.

Customers having this concern should have their vehicle repaired using the following repair procedure.

1. Verify customer concern.
2. Verify that there is no external damage to the radar sensor, or impact around the radar sensor causing the radar axis deviation.
3. Reboot the IDS to clear memory before reprogramming.
4. Using IDS 90.05 or later software, reprogram the Vehicle Control Module (VCM) to the latest calibration following the “Module Reprogramming” procedure.

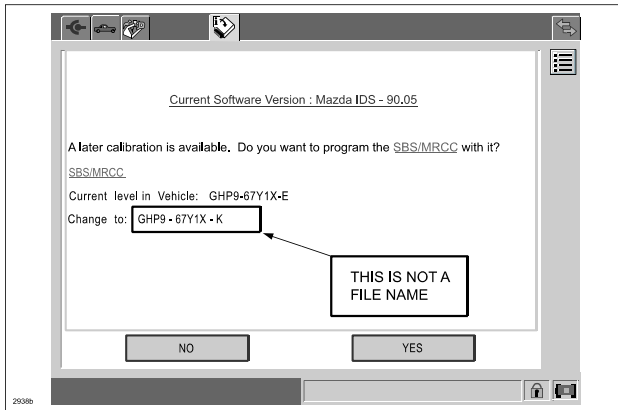
Figure 1: Subject for VCM reprogramming

- b. Either of the following screens (Figure 1 or 2) is displayed.
 - If the Figure 1 is displayed, the VCM is before the latest calibration. Click “YES” and follow the M-MDS instructions to reprogram the VCM.
 - If the Figure 2 is displayed, the VCM is already the latest calibration. This Service Information does not apply and refer to Workshop Manual for troubleshooting and repair.

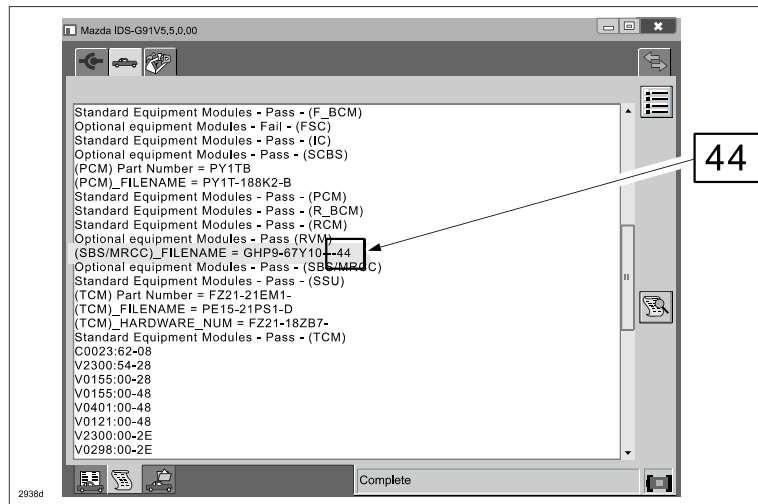
- c. After reprogramming, close the session. Then, open a new session and go to the “Log Viewer” screen. The programmed file name is displayed as shown in figure below. If the last two letters are “44”, the reprogramming has been successfully completed.
