<b>Subject:</b>  GROAN NOISE FROM FRONT WHEEL HUB	<b>Bulletin No:</b> 03-003/14
	<b>Last Issued:</b> 07/16/2014

2014-2015 Mazda6 vehicles with VINs lower than JM1 GJ \*\*\*\*\* 190589 (produced before June 01, 2014)  
2013-2014 CX-5

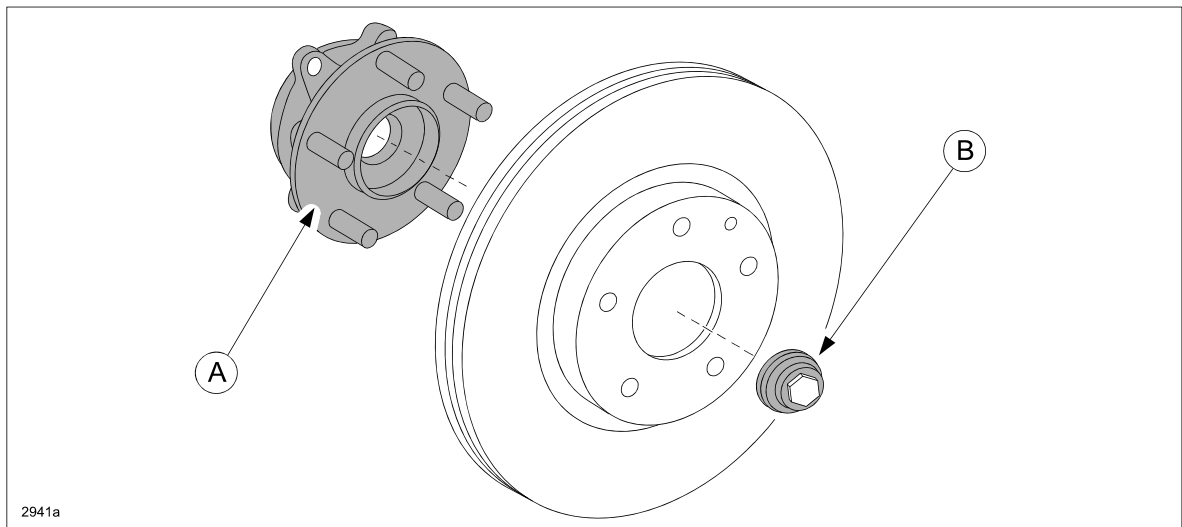
Some vehicles may exhibit a groan type noise from the front wheel hub bearing while driving at high speed or when cornering. This may be caused by front wheel hub bearing corrosion.

1. Verify customer concern.
2. Replace the affected front wheel hub (A) and locknut (B). Refer to MS3 online or Workshop Manual (section 03-12) removal/installation instructions for the front wheel hub and the locknut only.
  - CX-5 - WHEEL HUB COMPONENT REMOVAL/INSTALLATION [AWD]
  - Mazda6 - WHEEL HUB, STEERING KNUCKLE REMOVAL/INSTALLATION
