© 2014 Mazda Motor of America, Inc.

Subject: CD PLAYER DISPLAY CONCERNS	Bulletin No: 09-032/14
	Last Issued: 07/14/2014

2014 Mazda3 vehicles (with MAZDA CONNECT and CD player) with VINS lower than JM1BM**** ** 154022 (produced before December 01, 2013)

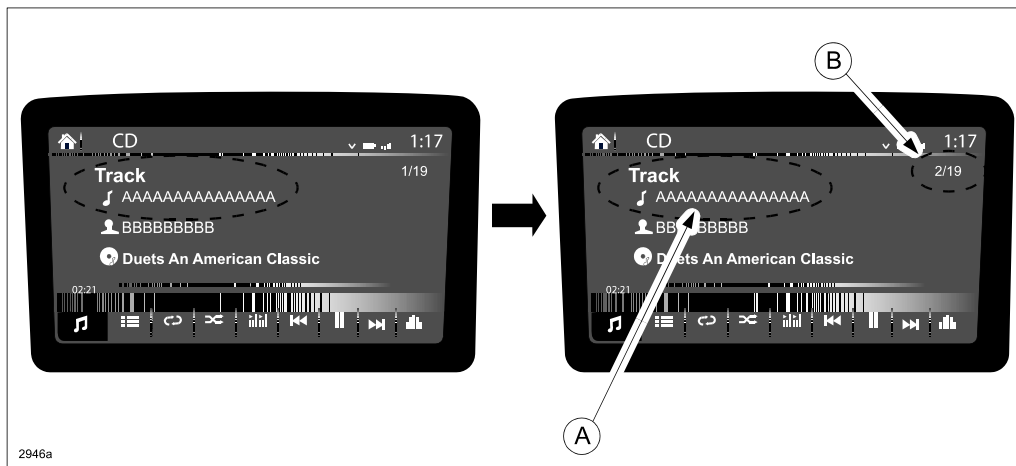
Symptom 1: The song title on the CD display (A) does not change when it goes to the next song. However, the track number (B) changes

This is caused by improper software of the CD player. The software of CD player has now been changed to correct this issue.

Customers having this concern should have their vehicle repaired using the following repair procedure.

1. Verify customer concern.
2. Check the software version.
 - a. Press the three buttons (Music (A) + Favorites (B) + Volume Mute(C)) on the commander switch at the same time for 2-5 seconds and the Diagnostic Test Screen will appear.
