Subject: RUBBER PROTECTOR PARTIALLY COMES OFF SIDE STEP MOLDING CAUSING A POOR APPEARANCE CONCERN	Bulletin No: 09-031/14
	Last Issued: 07/11/2014

2013 CX-5 vehicles with VINs lower than JM3KE*****162631 (produced before November 1, 2012)

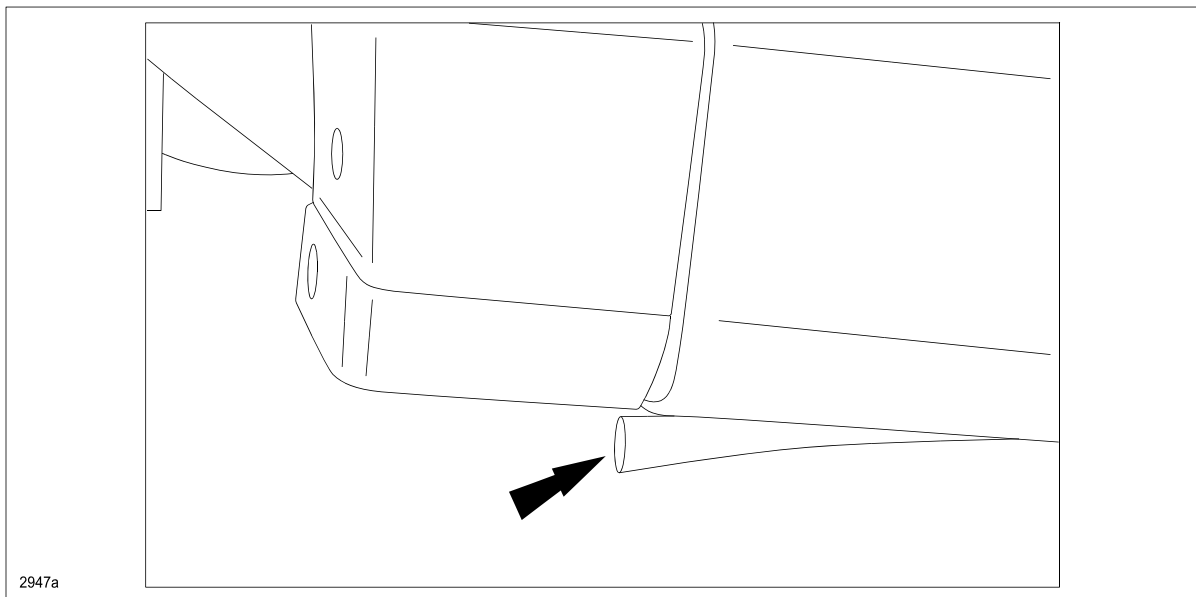
Some customers may complain that the rubber protector comes off the side step molding. The protector hangs down causing a poor appearance concern.

This concern may occur when the vehicle is driven in freezing temperatures. Snow and moisture adhere and freeze onto the rubber protector and when the door is opened, the rubber protector can tear or stretch, coming off the fasteners.

The material of the rubber protector around the fasteners has been changed to increase the holding force to the fasteners.

Customers having this concern should have their vehicle repaired using the following repair procedure.
