Subject: UNABLE TO ADJUST DRIVER SEAT UP OR DOWN - (MANUAL SEAT ONLY)	Bulletin No: 09-030/14
	Last Issued: 07/08/2014

2010-2012 CX-7 vehicles equipped with manual seats

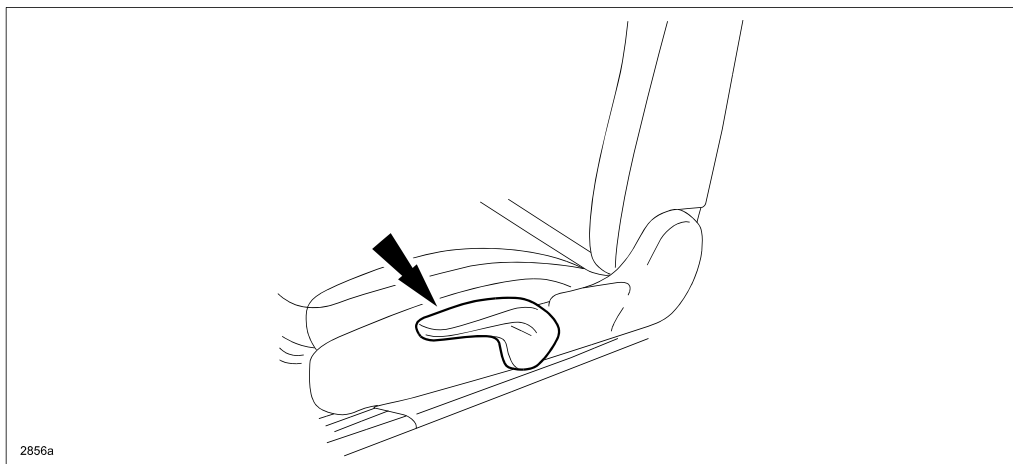
On some vehicles, it may be difficult to adjust the driver seat up or down using the manual seat lift lever.

This may be caused by a broken front seat side cover that interferes with the operation of the seat lifter mechanism. The cover may have been previously broken by an outside impact.

1. Verify the customer concern.
2. Replace the front seat side cover with a modified one according to the instructions on MS3 online or the Workshop Manual (section 09-13 FRONT SEAT SIDE COVER REMOVAL/INSTALLATION).
3. Verify the repair.
