© 2014 Mazda Motor of America, Inc.

Subject: A/C MODE SELECTOR DIAL DOES NOT STAY IN "DEFROSTER VENTS" POSITION - (MANUAL A/C ONLY)	Bulletin No: 07-001/14
	Last Issued: 07/08/2014

2013-2015 CX-5 vehicles equipped with manual type air conditioning system with VINs lower than JM3KE*****488298 (produced before June 1, 2014)

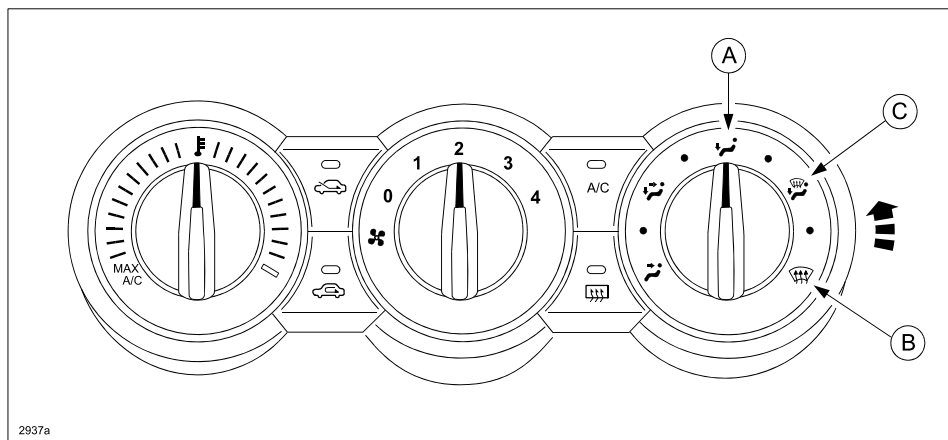
When selecting the "Defroster Vents" position (B) with the Mode Selector Dial (A), some customers may notice the dial does not stay in the "Defroster Vents" position and returns to the "Defroster/Floor Vents" position (C).

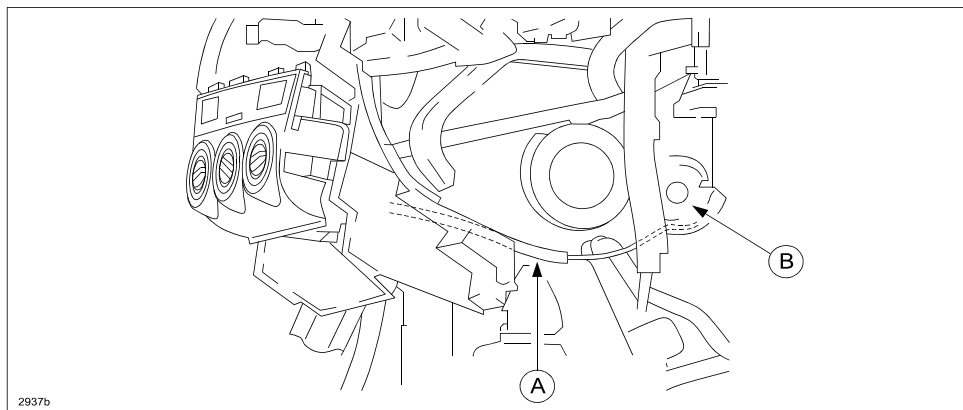
This concern may be due to a production variation. Some of the mode control wires (A) may be too long to transmit movement from the mode selector dial to the link (B). The length of the mode control wire has been shortened to eliminate this concern.

1. Replace the mode control wire with a modified one according to the instructions on MS3 online or the Workshop Manual (section 07-40 CLIMATE CONTROL UNIT REMOVAL/INSTALLATION [MANUAL AIR CONDITIONER])
2. Verify the repair.
