<b>Subject:</b>  RATTLE NOISE FROM FRONT DOOR GLASS	<b>Bulletin No:</b> 09-017/14
	<b>Last Issued:</b> 08/29/2014

2013-2014 CX-5 vehicles with VINs lower than JM3KE\*\*\*\*\*433172 (produced before January 13, 2014)

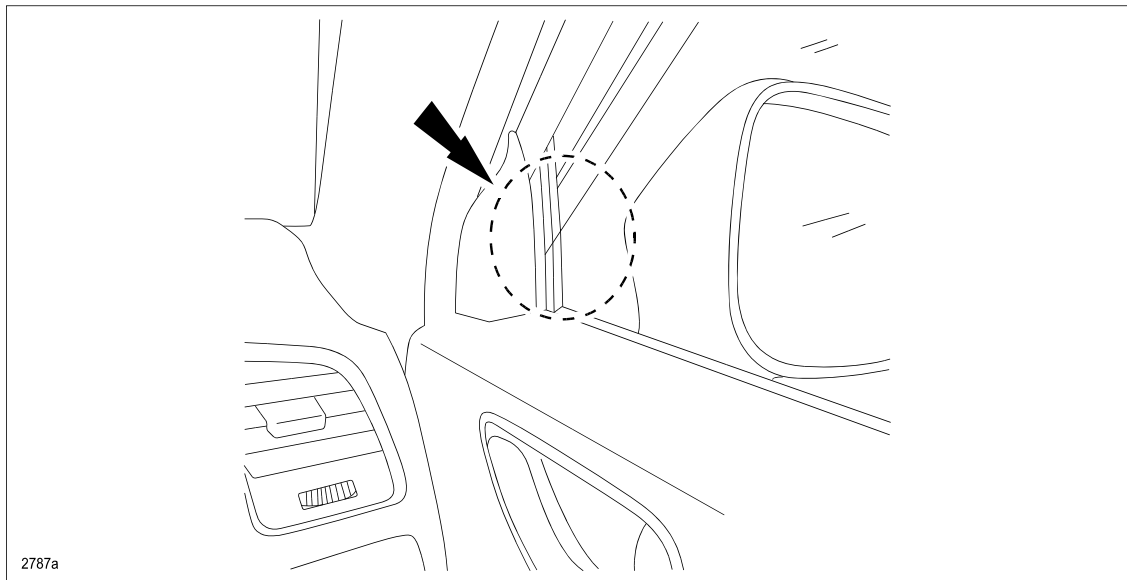
Some vehicles may experience a rattle noise from the front door glass when driving with the window open approx. 1/2 to 4 inches (1 - 10 cm).

The rattle noise may be caused by insufficient glass run channel holding force. To eliminate this concern, the shape of glass run channel has been changed in order to increase the holding force.
