Subject: A/T SHIFT LEVER IS HARD TO MOVE	Bulletin No: 05-009/14
	Last Issued: 08/29/2014

2014 Mazda6 with VINs lower than JM1GJ*****162912 (produced before Dec. 3, 2013)

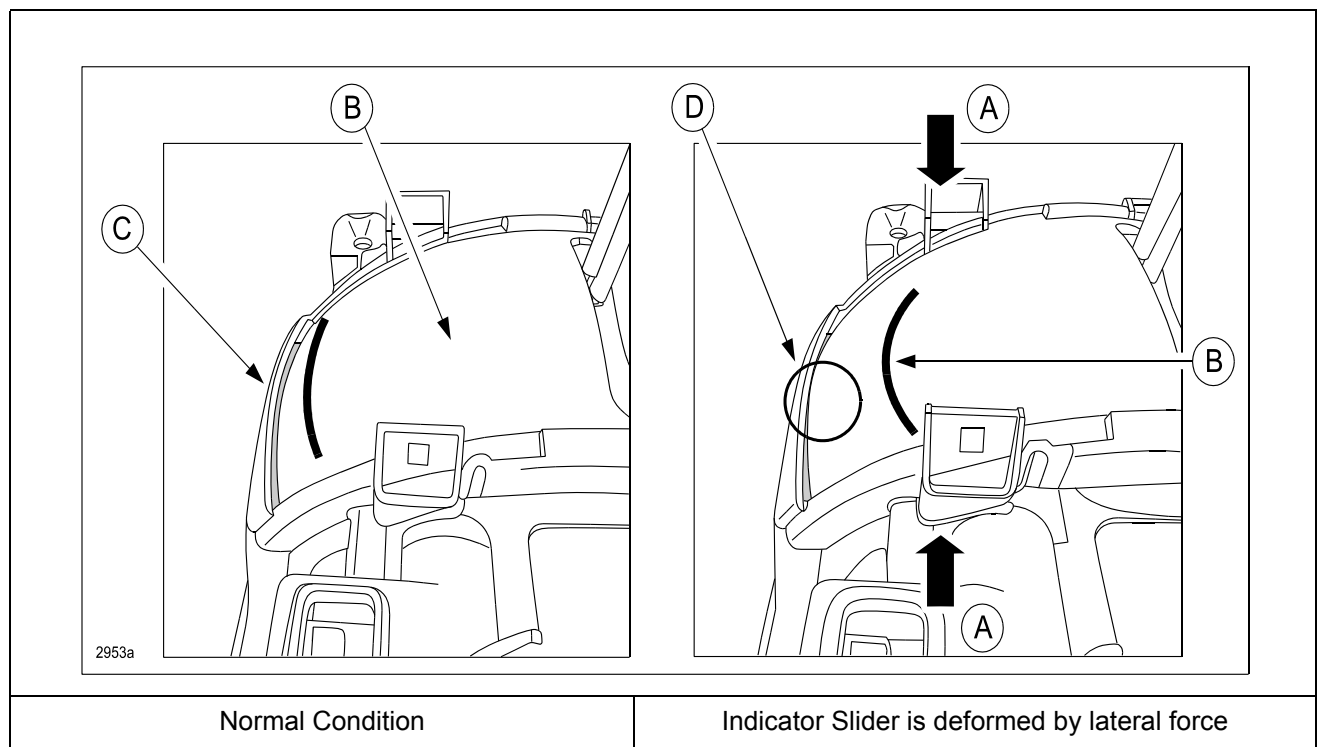
Some customers may find it difficult or hard to move the A/T shift lever.

When the driver or front passenger's leg contacts the center console, lateral force (A) may deform the indicator slider (B), causing the slider edge to contact the arched part of the set plate (D). This may cause damage to the indicator slider (B) and/or hard A/T shift lever movement.

Customers having this concern should have their vehicle repaired using the following repair procedure.
