© 2014 Mazda Motor of America, Inc.

Subject: WIND NOISE FROM DOOR WINDOW EDGE(S) AT 37 MPH OR HIGHER	Bulletin No: 09-036/14
	Last Issued: 08/29/2014

2014-2015 Mazda6 vehicles with VINs lower than JM1 GJ ***** 167429 (produced before January 07, 2014)

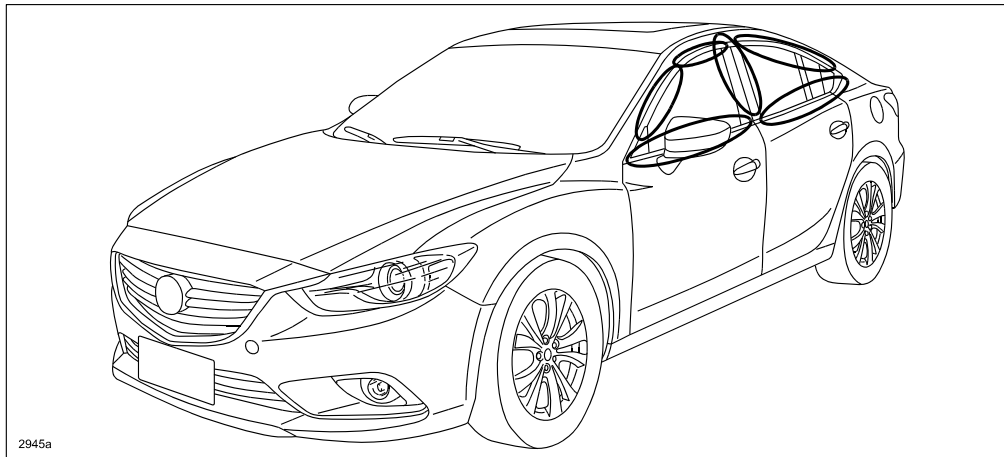
Some vehicles may exhibit a wind noise from the door window edge(s), while driving. The wind noise is most pronounced at approximately 50 mph (81 km/h) on a smooth road. The wind noise may be caused by air passing through gaps between the door edge and the corresponding body panel.

Customers having this concern should have their vehicle repaired using the following repair procedure.
