Subject: RATTLE, SNAP, POP OR CRACK NOISE FROM BOTTOM OF A-PILLAR	Bulletin No: 09-001/14
	Last Issued: 08/01/2014

2014 Mazda3

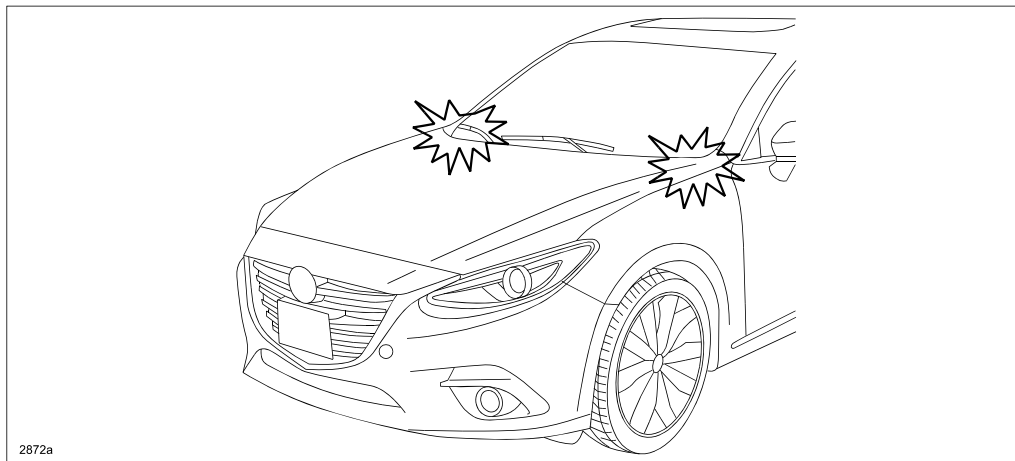
Some vehicles may exhibit a noise from the bottom of the A-pillar when driving on rough roads or over bumps. This is caused by the cowl upper plate and/or dash upper panel interfering with the wiper bracket. For the affected vehicles, a clearance needs to be created between the wiper bracket and cowl upper plate and between the wiper bracket and dash upper panel.

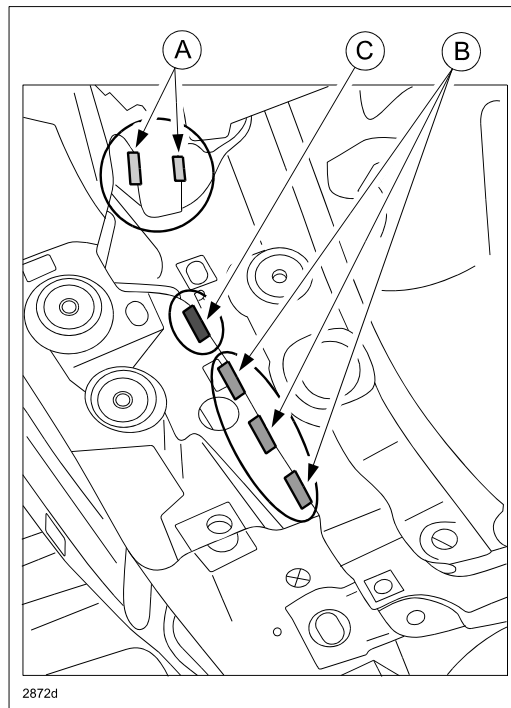
Locations to create clearance

- Areas A and B: Create a clearance for all vehicles
- Area C: Create a clearance for vehicles with VIN range JM1BM*****100001 - 189735
