<b>Subject:</b> <b>WHITE FELT VISIBLE FROM FRONT DOOR TRIM JOINT CAUSING POOR APPEARANCE</b>	<b>Bulletin No:</b> 09-042/14
	<b>Last Issued:</b> 09/26/2014

2014 Mazda3 vehicles with VINs lower than 3MZBM\*\*\*\*EM117321 (produced before May 19, 2014)

2015 Mazda3 vehicles with VINs lower than 3MZBM\*\*\*\*FM100801 (produced before May 19, 2014)

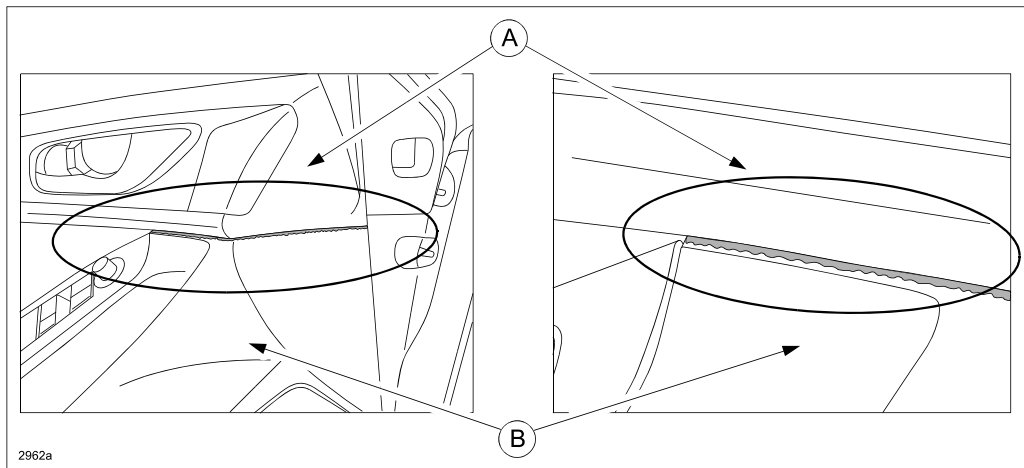
Some vehicles may exhibit a white felt (used for noise insulation) visible through the gap between the upper (A) and lower (B) front door trim, causing a poor appearance.

The cause of this is that the color of the felt and the glue is not appropriate and highly visible. To correct the problem, the color of the felt and the glue has been changed to one that resembles the door trim. The production control and the inspection have also been improved to eliminate the protruding felt.

1. Verify customer concern.
2. Replace the concerned front door trim with a modified one according to the instructions on MS3 online or the Workshop Manual (section 09-17 FRONT DOOR TRIM REMOVAL/INSTALLATION).
3. Verify repair.
