<b>Subject:</b>  REAR DOOR WEATHERSTRIP OUT OF POSITION	<b>Bulletin No:</b> 09-041/14
	<b>Last Issued:</b> 09/24/2014

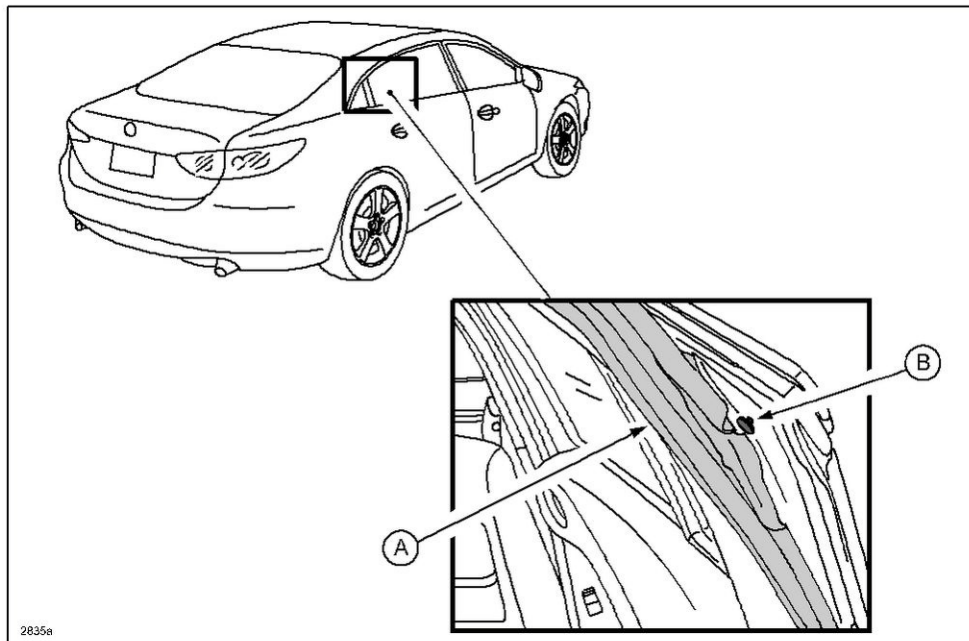
Some customers may have a concern with the top edge of the rear door weatherstrip (A) detached (coming off / falling off) from fastener (B).

Customers having this concern should have their vehicle repaired using the following repair procedure.

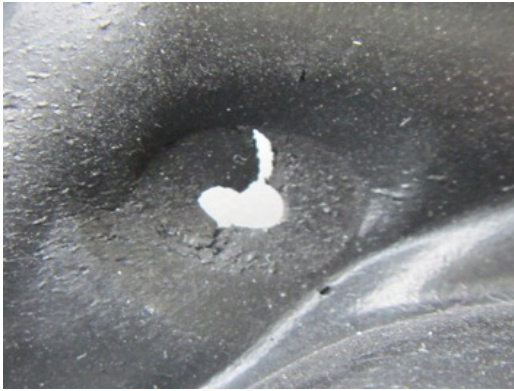
- If cracked as shown "NG", proceed to REPAIR PROCEDURE A.
- If damaged, but not cracked completely as shown "OK", proceed to REPAIR PROCEDURE B.

NG	Proceed to REPAIR PROCEDURE A. Replace weatherstrip. Replacement weatherstrip includes new fastener.
OK	Proceed to REPAIR PROCEDURE B. Replace fastener.
