Subject: CHIRP NOISE FROM REAR SHOCK ABSORBERS	Bulletin No: 02-003/14
	Last Issued: 09/18/2014

2014 CX-5 vehicles with VINs between JM3 KE ***** 387092 and JM3 KE ***** 490721 (produced before June 06, 2014)

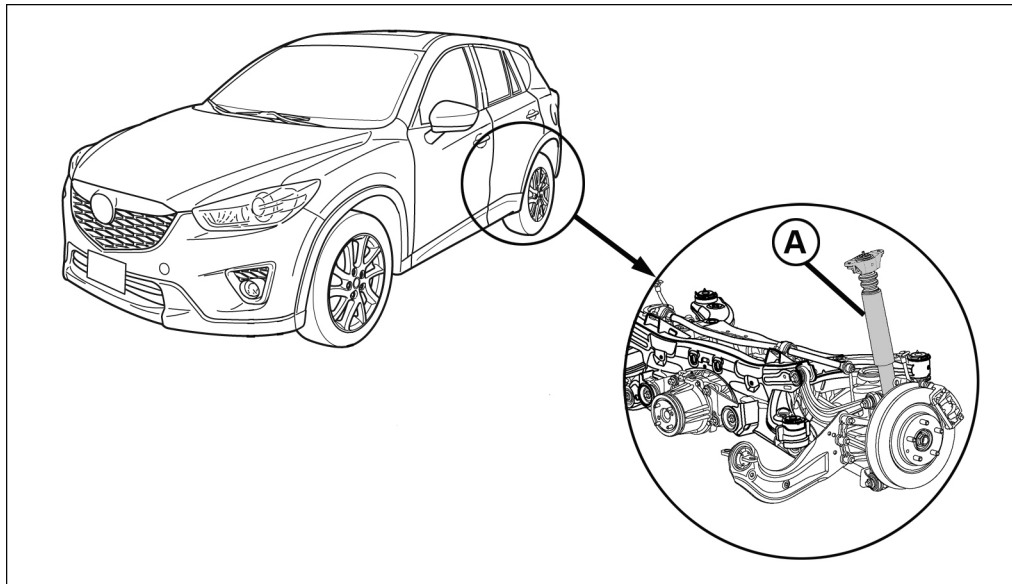
Some vehicles may exhibit a chirp noise from the rear shock absorbers (A) when driving on a rough road or passing over a speed bump. Visual inspection of the shock absorbers show no external damage or oil leakage.

1. Verify customer concern.
2. Replace the rear shock absorber. Refer to MS3 online or Workshop Manual (section 02-14 REAR SHOCK ABSORBER REMOVAL/INSTALLATION).

NOTE: Only replaced the affected side.
