Subject: CD PLAYER DISPLAY CONCERNS	Bulletin No: 09-032/14
	Last Issued: 09/16/2014

2014 Mazda3 vehicles (with MAZDA CONNECT and CD player) with VINS lower than JM1BM**** ** 154022 (produced before December 01, 2013)

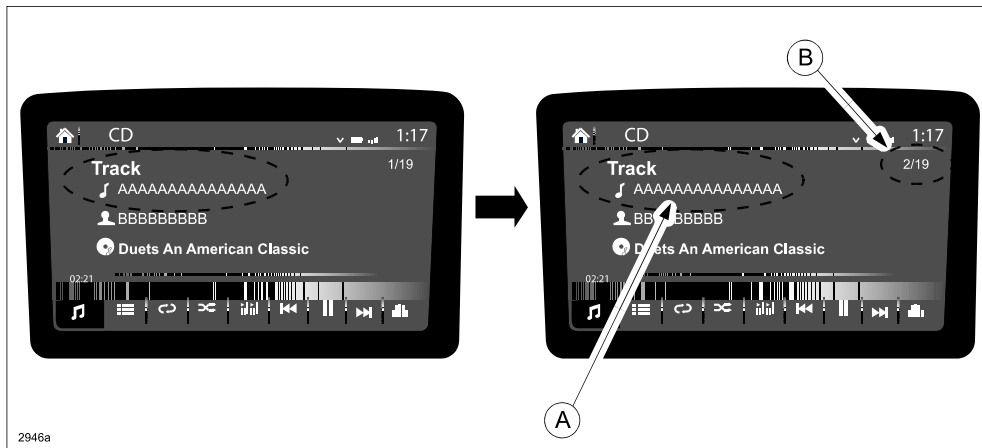
Symptom 1: The song title on the CD display (A) does not change when it goes to the next song. However, the track number (B) changes

This is caused by improper software of the CD player. The software of CD player has now been changed to correct this issue.

1. Verify customer concern.
2. Check the software version.
 - a. Turn the ignition switch to ACC or ON.
 - b. Press the three buttons (Music (A) + Favorites (B) + Volume Mute(C)) on the commander switch at the same time for 2-5 seconds and the Diagnostic Test Screen will appear.

- d. Check the last two digits of the CD player software version.
 - If two digits are "32", this Service Bulletin is not applicable.
 - If software version is below "32", go to the next step.
3. Order a CD with update software from MStore (CD Player Update P/N 9999-95-CD32-14) or burn the update software (A-000032) to a CD (Music Type). DO NOT use a DVD. The update software is available on MS3 under "IDS/Infotainment -> Mazda Connect Updates."

NOTE: When burning the update software to a CD, make sure it is burned as a Master file and NOT a Live file. If burned as a Live file, the CD player will not read it.
 4. Turn the ignition switch to "ACC" or "ON", then insert the update CD to the CD player slot. The reprogramming starts automatically. After the reprogramming is completed (approx. 3 minutes), the CD ejects automatically.
 5. Turn the ignition switch to OFF, then back to ACC or ON.
 6. Make sure the last two digits of the CD player software version is "32".
 7. Turn the ignition switch "OFF", then remove the CD from the CD player slot.
 8. Verify repair.
