© 2014 Mazda Motor of America, Inc.

Subject: CRACKING NOISE FROM WINDSHIELD AND/OR REAR WINDOW	Bulletin No: 09-025/14
	Last Issued: 09/03/2014

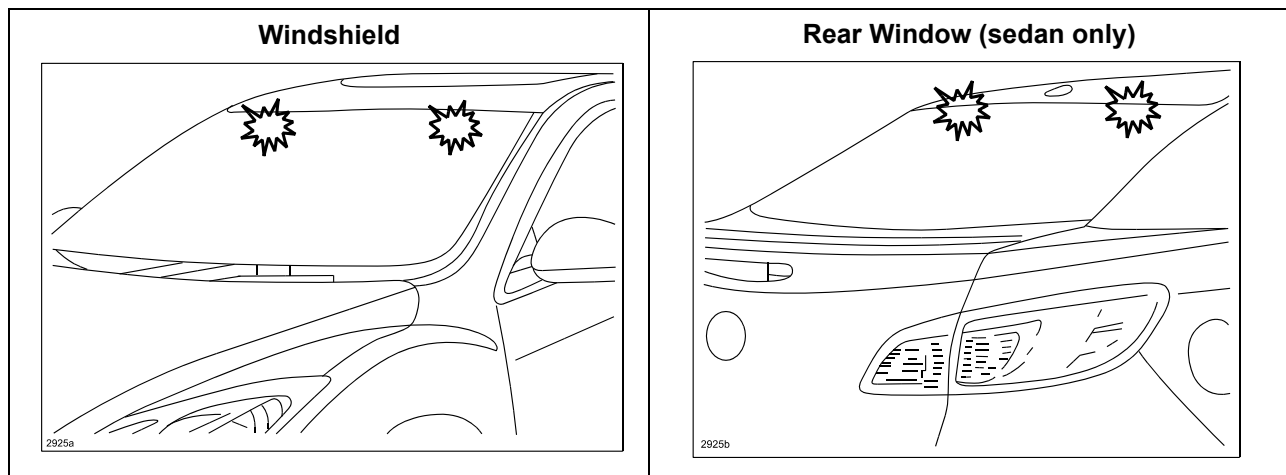
Some vehicles may exhibit a cracking noise originated at the positioning pins near the top corners of the windshield and/or rear window when driving on uneven road surface. This happens when the ambient temperature is approximately 14 °F (-10 °C) or lower and the vehicle cabin has not yet warmed up. The noise is caused by the windshield and/or rear window locating stopper contacting the panel.

Customers having this concern should have their vehicle repaired using the following repair procedure.
