Service Bulletin

Subject:	ubject: ROUGH IDLE WITH MIL ON AND DTC P0015 / P0524	Bulletin No:	01-009/14
		Last Issued:	09/03/2014

2012-2014 Mazda3 SKYACTIV

2013-2014 CX-5 SKYACTIV

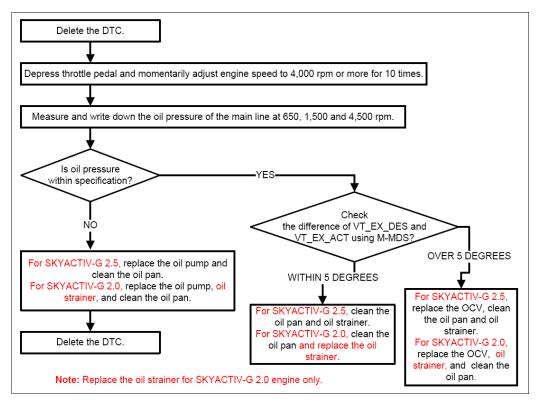
Only P0015 is stored:

- P0015:00 Exhaust CMP timing over-retarded
- P0524:00 Engine oil pressure too low

This is caused by a drop in engine oil pressure due to a piece of foreign object stuck on the oil pump pressure relief valve or OCV. The temporary entry of the foreign object triggers a MIL illumination, but rough idle will not be produced until a later time.

1. Delete the DTC.

- 2. Depress the throttle pedal and momentarily adjust the engine speed to 4,000 rpm or more for 10 times.
- 3. Measure the main line oil pressure at 650 rpm, 1,500 rpm and 4,500 rpm. Refer to MS3 online instructions or Workshop Manual section 01-11 OIL PRESSURE INSPECTION.
 - a. Connect M-MDS to monitor ECT, OIL_TEMP and RPM.
 - b. Start the engine and turn off all electrical loads such as A/C, headlights, etc.
 - c. Warm up the engine until ECT and OIL_TEMP reach 90 °C (194 °F) or more.
 - d. Turn off all electrical loads such as A/C and headlights.
 - e. Wait until RPM on IDS becomes stable at 650 rpm. DO NOT read RPM on the tachometer in the vehicle.
 - f. Measure and write down the main oil line pressure at 650 rpm, 1,500 rpm and 4,500 rpm.

• If Abnormal oil pressure is observed:

1a) For SKYACTIV-G 2.5 engine, replace the oil pump and clean the bottom of the oil pan with a clean cloth. Refer to MS3 online instructions or Workshop Manual section 01-11 OIL PAN REMOVAL/INSTALLATION [SKYACTIV-G 2.0, SKYACTIV-G 2.5].

1b) For SKYACTIV-G 2.0 engine, replace the oil pump, oil strainer, and clean the bottom of the oil pan with a clean cloth. Refer to MS3 online instructions or Workshop Manual section 01-11 OIL PAN REMOVAL/INSTALLATION [SKYACTIV-G 2.0, SKYACTIV-G 2.5].

If Normal oil pressure is observed:

1) Verify that the difference of VT_EX_DES (Exhaust valve opening angle - target) and VT_EX-ACT (Exhaust valve opening angle - actual) is within 5 degrees (between 1,500 rpm and 2,000 rpm) using M-MDS.

1) Replace the oil control valve (OCV).
