<b>Subject:</b>  REAR CONSOLE LID IS LOOSE	<b>Bulletin No:</b> 09-045/14
	<b>Last Issued:</b> 10/23/2014

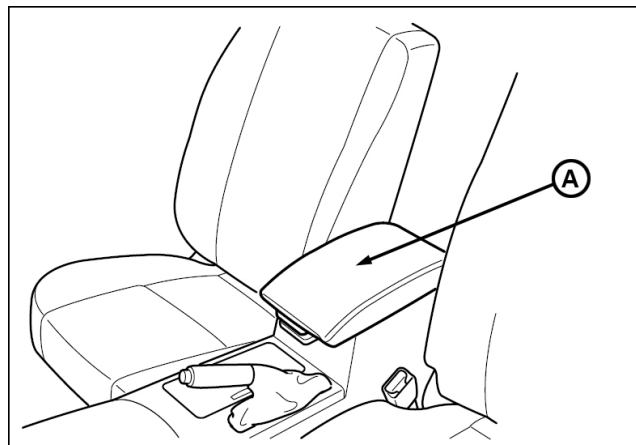
Some customers may complain about a loose rear console lid (A).

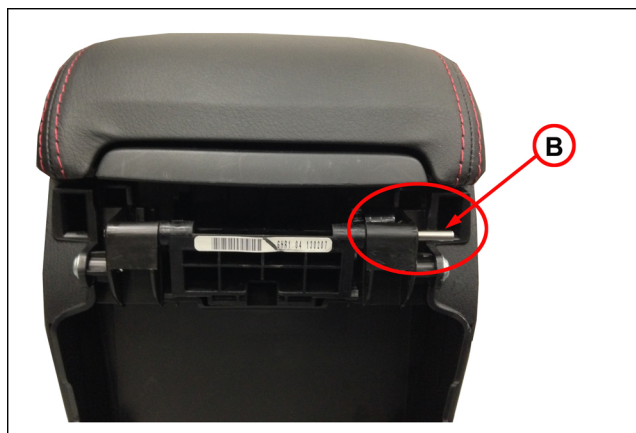
This may be caused by hinge pins coming partially off (B) or completely off.
