Subject: CHIRP NOISE FROM REAR SHOCK ABSORBERS	Bulletin No: 02-003/14
	Last Issued: 10/23/2014

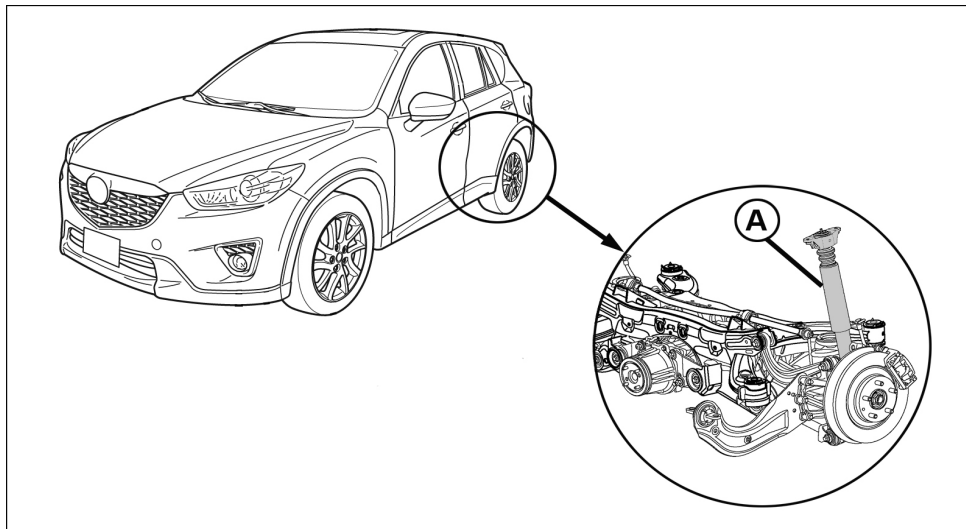
Some vehicles may exhibit a chirp noise from the rear shock absorbers (A) when driving on a rough road or passing over a speed bump. Visual inspection of the shock absorbers show no external damage or oil leakage.

1. Verify customer concern.
2. Replace the rear shock absorber. Refer to MS3 online or Workshop Manual (section 02-14 REAR SHOCK ABSORBER REMOVAL/INSTALLATION).

NOTE: Only replaced the affected side.
