Subject: CHECK ENGINE LIGHT ON WITH DTC P2610	Bulletin No: 01-017/14
	Last Issued: 10/17/2014

- 2013-2016 CX-5
- 2014-2016 Mazda6
- 2014-2015 Mazda3

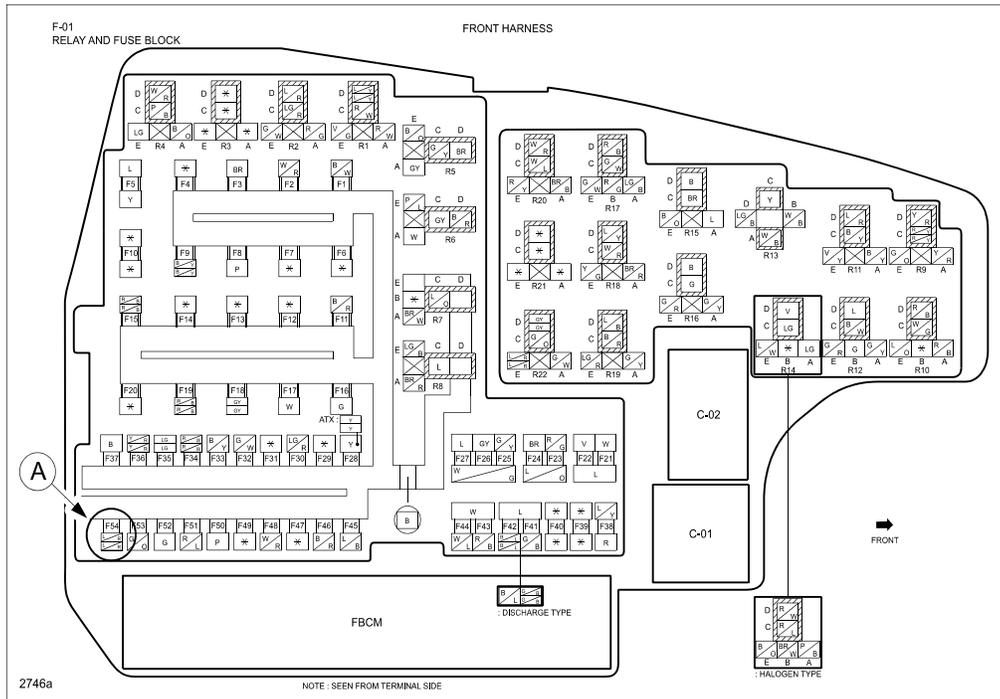
Some vehicles may experience MIL illumination with DTC P2610 (Instrument cluster internal engine off timer performance problem) stored in memory after engine start and room fuse 15A (A) removed.

1. Verify DTC P2610 is stored in PCM memory.
2. With the ignition off, install ROOM fuse 15A.
3. Clear DTC P2610 from PCM memory using IDS.
4. Verify no other DTCs are stored in memory. If so, troubleshoot them according to the MS3 online instructions or Workshop Manual.

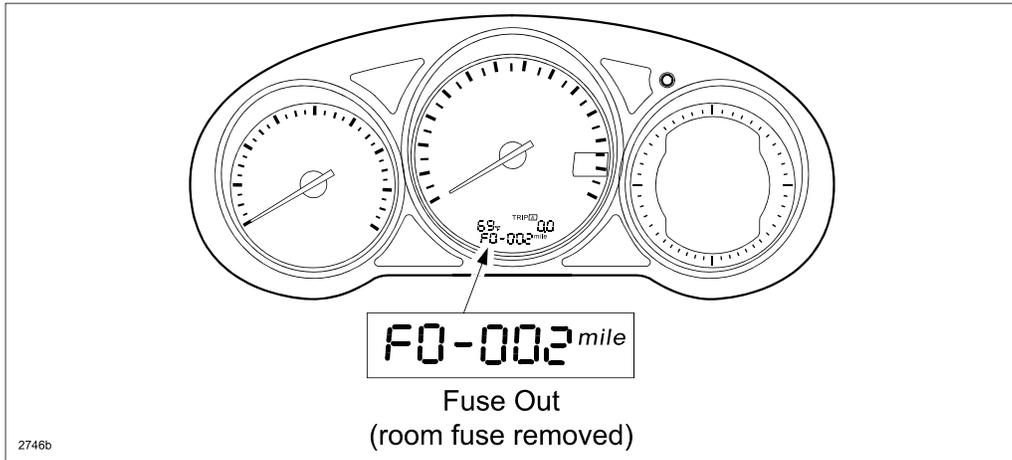
NOTE: The odometer will display “F0-002” during transport mode (room fuse 15A removed). Transport mode is canceled when room fuse 15A is installed or the vehicle odometer is more than 12.4mi (20km).
