Subject: CORROSION ON UPPER SHROUD CAUSING POOR APPEARANCE	Bulletin No: 09-043/14
	Last Issued: 10/10/2014

2013 CX-5 with VINs lower than JM3KE*****152861 (produced before Oct. 1, 2012)

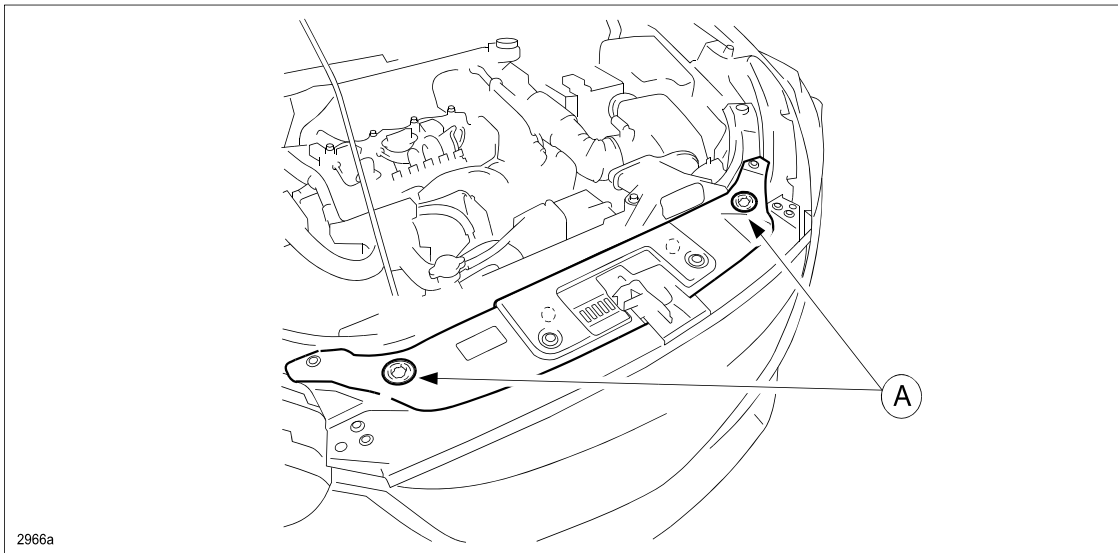
Some vehicles may exhibit corrosion on the upper shroud member where the hood stopper rubber makes contact (A). The paint surface is damaged by the hood stopper rubber, which causes corrosion and a poor appearance concern.

A protection seal has been attached to the upper shroud member to prevent paint damage.
