Subject: DIFFICULT TO MOVE SELECTOR LEVER OUT OF "P" RANGE	Bulletin No: 05-010/14
	Last Issued: 10/03/2014

2010-2015 CX-9

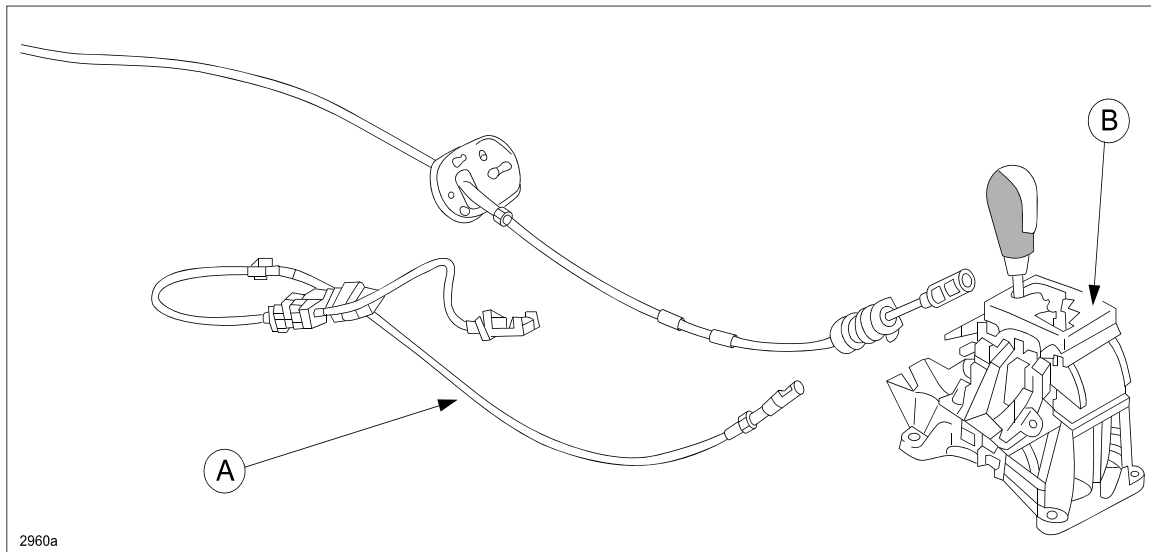
This concern may be caused accidentally by the customer spilling a drink around the selector lever. When the spilled liquid reaches the interlock cable and freezes overnight, it causes the customer to have difficulty moving the selector lever out of "P" range the next morning.

1. Verify the customer concern.
2. Replace the interlock cable (A) according to the instructions on MS3 online or the Workshop Manual (section 05-18 AUTOMATIC TRANSAXLE SHIFT MECHANISM REMOVAL/INSTALLATION).

NOTE: Advise the customer to take the necessary precautions to avoid spilling liquids around the selector lever (B) area.
