<b>Subject:</b> <b>RATTLE NOISE FROM INSTRUMENT PANEL AND/OR CREAK NOISE FROM A-PILLAR OVER ROUGH / BUMPY ROADS</b>	<b>Bulletin No:</b> 09-002/14
	<b>Last Issued:</b> 10/03/2014

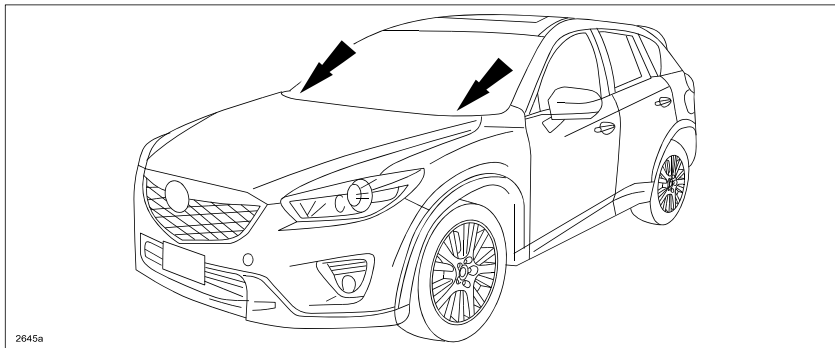
The rattle noise may be caused by low cowl panel (A) mounting bolt (B) torque.

2. Retighten all ten (10) cowl panel bolts (A) to:  
**Tightening Torque: 17-22 ft. lbs {22-30 Nm, 2.3-3.0 kgf-m}**
3. Reinstall the cowl grille according to the online MS3 instructions or the Workshop Manual (section 09-16 COWL GRILLE REMOVAL/INSTALLATION).

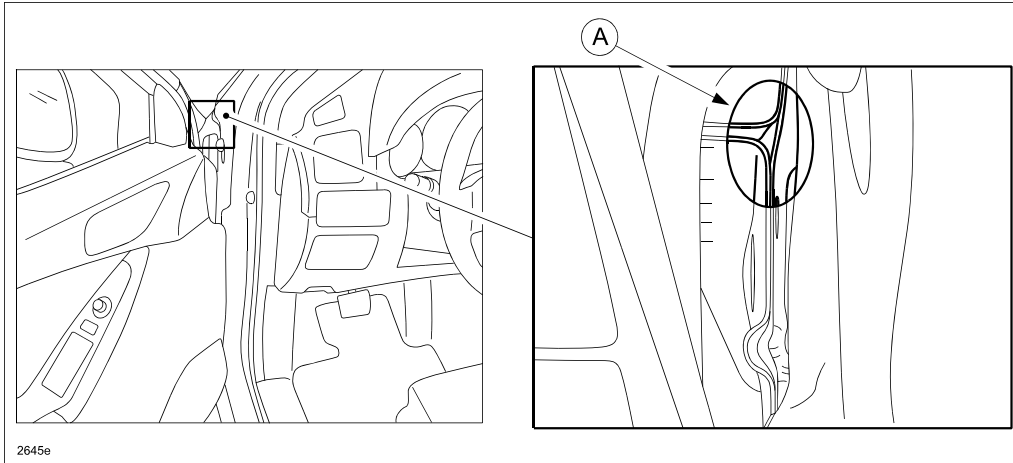
This noise may be caused by two joined panels (A) scraping together at the A-pillar. The panel weld areas have been improved during the mass-production of vehicles with VINs JM3KE\*\*\*\*\*128359 (produced June 1, 2012) or higher.

Enlarge the clearance between two (2) panels (A) using an appropriate tool (i.e. flat-blade screwdriver).
