<b>Subject:</b> <b>EXCESSIVE CONDENSATION OR WATER WITHIN THE HEADLAMP ASSEMBLY</b> <b>- CAUTION</b>	<b>Bulletin No:</b> 09-049/14
	<b>Last Issued:</b> 11/24/2014

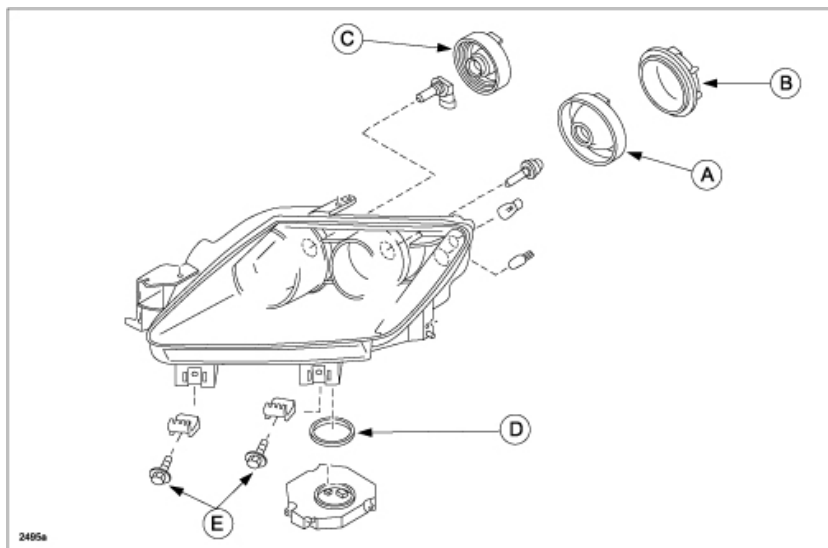
When dealing with customer complaints of excessive condensation and/or water within the headlamp unit, first determine if all the bulb sockets are present and correctly installed. In most cases you will find that the Bulb Seal No. 1 (A) or HID Bulb Seal No. 1 (B) and Bulb Seal No. 2 (C) socket covers have not been correctly installed or are missing due to improper prior repairs (i.e., customer replacing the headlamp bulbs or body shop not transferring them when replacing the headlamp unit(s) due to a collision). Any damage caused by missing socket covers, HID module seal (D), or missing bumper brackets (E) is not covered by warranty policy.
