Subject: REAR CONSOLE LID IS LOOSE	Bulletin No: 09-045/14
	Last Issued: 11/24/2014

2014-2015 Mazda6 vehicles with VINs lower than JM1 GJ ***** 186473 (produced before May 14, 2014)

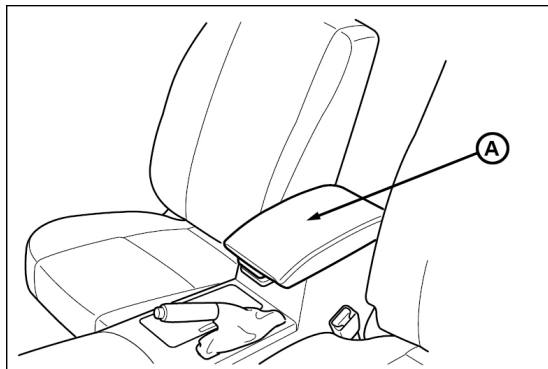
Some customers may complain about a loose rear console lid (A).

Customers having this concern should have their vehicle repaired using the following repair procedure.

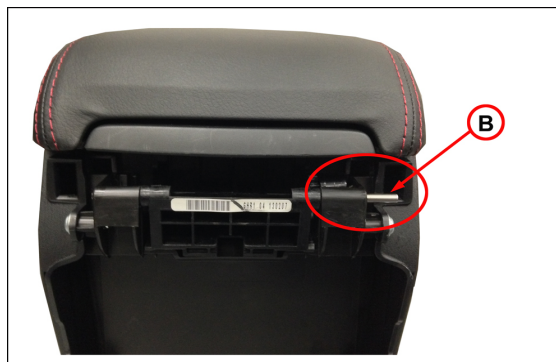
This may be caused by hinge pins coming partially off (B) or completely off.

3. Re-install the rear console lid pin(s) back to the original position.

4. Install a new rear console panel. (See PART(S) INFORMATION)

NOTE: The shape of the rear console panel has been changed, by adding a stopper rib to prevent the pin from coming off.
