Subject: CLOCK RESETS TO 1:00 BY ITSELF AND / OR DISPLAY IS BLANK / FREEZES	Bulletin No: 09-047/14
	Last Issued: 11/4/2014

2014-2015 Mazda6 vehicles (with Automatic Climate Control) with VINs lower than JM1 GJ ***** 210201 (produced before September 22, 2014)

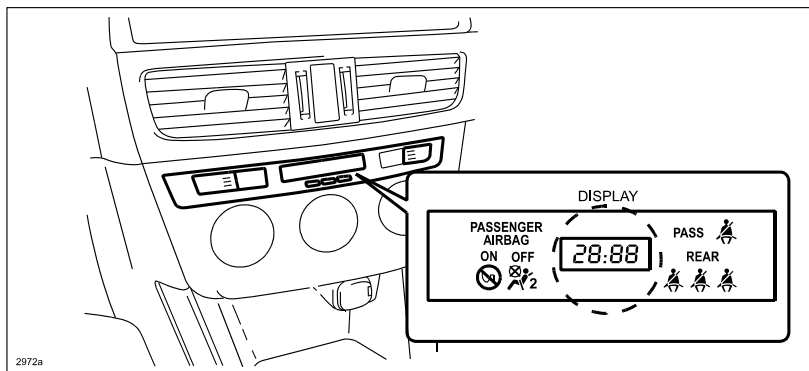
- The clock resets to 1:00 by itself.
- The clock display is blank.
- The clock display freezes.
- The clock displays a wrong time.

Internal failure of the climate control unit may be the cause.

1. Verify customer concern.
2. Replace the climate control unit. Refer to MS3 online or Workshop Manual (section 07-40 CLIMATE CONTROL UNIT REMOVAL/INSTALLATION [FULL-AUTO AIR CONDITIONER]).
3. Verify repair.
