© 2014 Mazda Motor of America, Inc.

<b>Subject:</b> <b>CHIRP / CLUNK NOISE FROM REAR SHOCK ABSORBERS</b>	<b>Bulletin No:</b> 02-003/14
	<b>Last Issued:</b> 12/30/2014

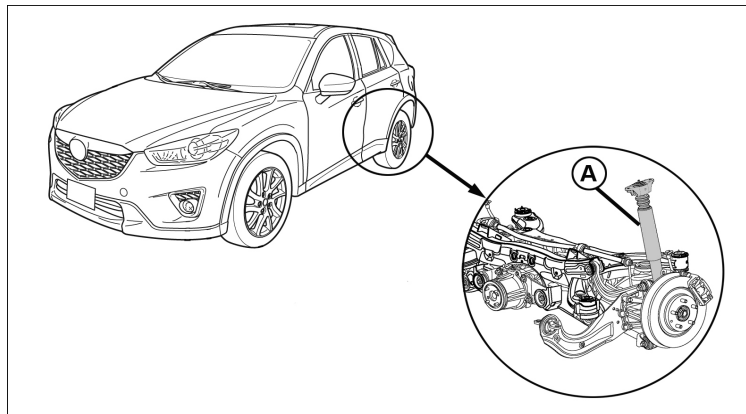
Some vehicles may exhibit a chirp/clunk type noise from the rear shock absorbers (A) when driving on a rough road or passing over a speed bump. Visual inspection of the shock absorbers show no external damage.

1. Verify customer concern.
2. Replace the rear shock absorber. Refer to MS3 online or Workshop Manual section 02-14:
  - CX-5 - REAR SHOCK ABSORBER REMOVAL/INSTALLATION
  - Mazda6 - REAR SHOCK ABSORBER REMOVAL/INSTALLATION

**NOTE:** Only replace the affected side.
