# Service Bulletin

Subject:	Bulletin No:	07-001/14
A/C MODE SELECTOR DIAL DOES NOT STAY IN "DEFROSTER VENTS"		
POSITION - (MANUAL A/C ONLY)	Last Issued:	12/03/2014

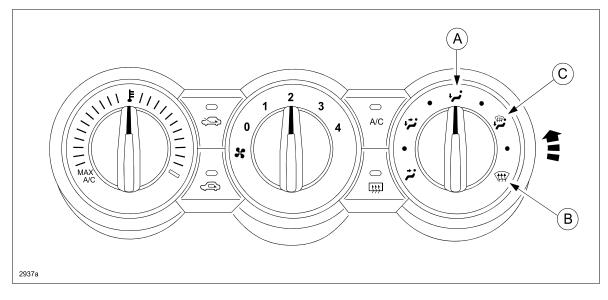
- Some customers may complain about one or both of the following symptoms:
  - When selecting the "Defroster Vents" position (B) with the Mode Selector Dial (A), the dial does not stay in the "Defroster Vents" position and returns to the "Defroster/Floor Vents" position (C).
  - When rotating the Mode Selector Dial (A) to the "Defroster Vents" position (B), it may be difficult to tell if the Mode Selector Dial is firmly in the "Defroster Vents" position.

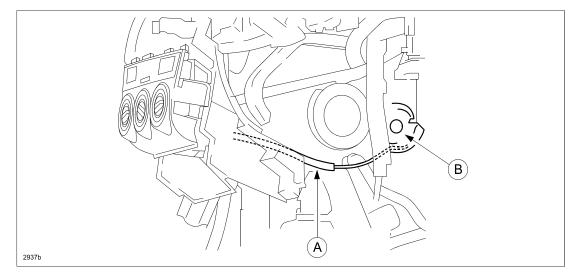
This concern may be due to a production variation. Some of the mode control wires (A) may be too long to transmit movement from the mode selector dial to the link (B). The length of the mode control wire has been shortened to eliminate this concern.

Customers having this concern should have their vehicle repaired using the following repair procedure.

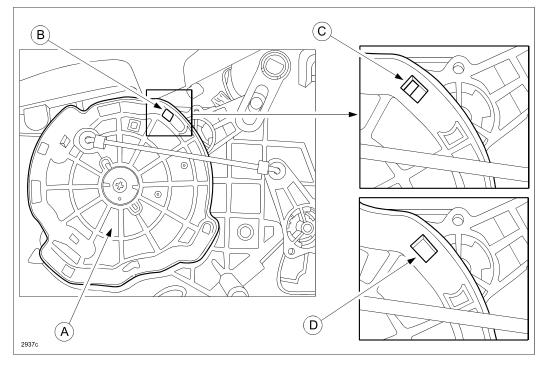
- 3. Rotate the mode selector dial so it stays firmly in the "Defroster Vents" position.
- 4. Verify the mode is correctly selected by checking the position of the air flow mode main link (A), as shown below.
  - (B) OK: If the boss is visible through the square hole, proceed to Step 7.
  - (C) OK: If only half of the boss is visible through the square hole, proceed to Step 7.
  - (D) NG: If the boss is not visible through the square hole, proceed to Step 5.
