Service Bulletin Mazda North American Operations

Subject:	ect: WHISTLE NOISE FROM OUTER MIRROR WHILE DRIVING	Bulletin No:	09-051/14
		Last Issued:	12/17/2014

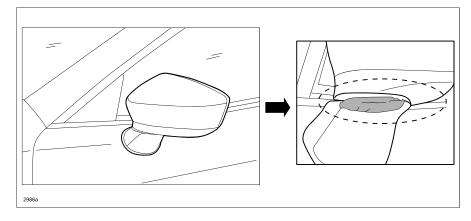
Some vehicles may exhibit a whistle noise from the outer mirror while driving at 37 mph (60 km/h) or more. This noise may be caused by air passing through a gap in the mirror base cover. To correct the problem, the shape of the mirror base cover has been changed.

- 1. Verify customer concern.
- 2. If the whistle noise was verified, apply masking tape to the mirror base to seal the gap as shown below (to both side mirrors), then test drive in the same condition to see if the whistle noise decreases.
