<b>Subject:</b> INFORMATION DISPLAY SHOWS "FOW INSPECTION REQUIRED" AND DTC C1A67:78 IS STORED	<b>Bulletin No:</b> 01-016/14
	<b>Last Issued:</b> 12/17/2014

2014 Mazda6 vehicles with VINs lower than JM1 GJ \*\*\*\*\* 149082 (produced before October 01, 2013)

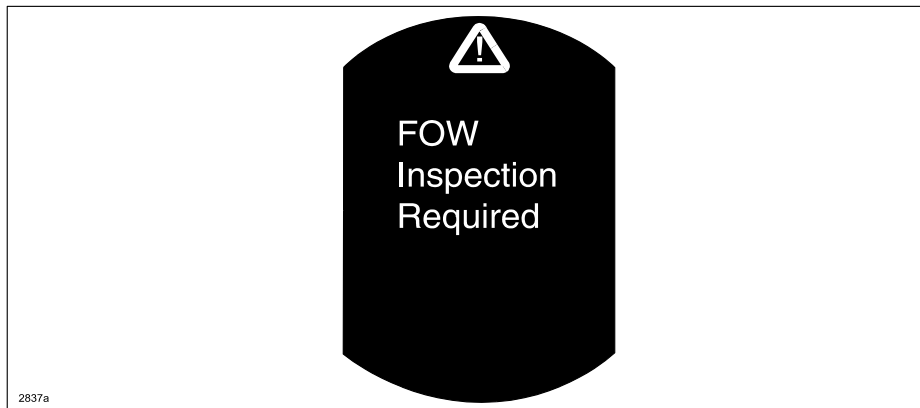
Some customers may experience a MRCC malfunction when driving at speeds above 25 mph (40 km/h) for approximately 10 hours or more with MRCC set. Instrument cluster information display shows "FOW INSPECTION REQUIRED" and DTC C1A67:78 (Radar sensor axis is deviated) is stored. This is caused by MRCC no obstacle detection during a long drive.

1. Verify customer concern.
2. Verify that there is no external damage to the radar sensor, or impact around the radar sensor causing the radar axis deviation.
3. Reboot the IDS to clear memory before reprogramming.
4. Using IDS 90.05 or later software, reprogram the Vehicle Control Module (VCM) to the latest calibration following the “Module Reprogramming” procedure.

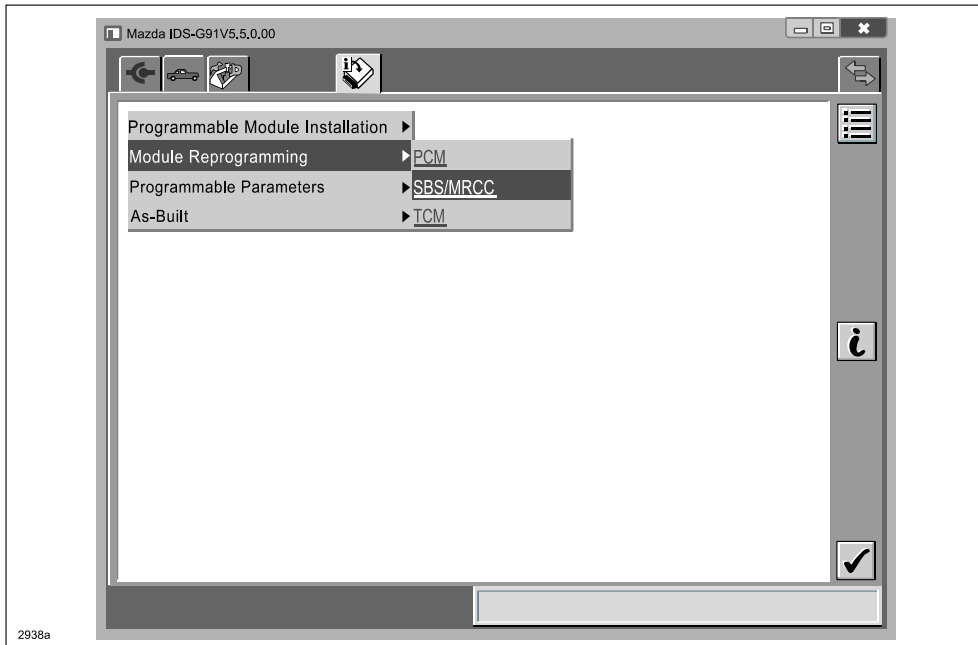
**NOTE:** The menu “SBS/MRCC” appears regardless of the equipment of MRCC System. For vehicles without the MRCC System, do not click this menu.

- a. Select “Module Reprogramming”, then select “SBS/MRCC”.

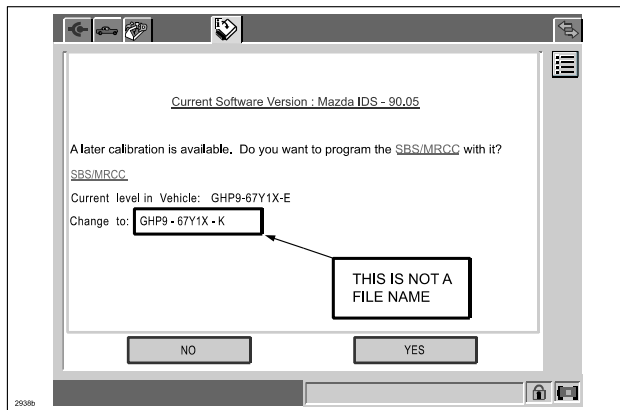
Figure 1: Subject for VCM reprogramming

- b. Either of the following screens (Figure 1 or 2) is displayed.
- If the Figure 1 is displayed, the VCM is before the latest calibration. Click “YES” and follow the M-MDS instructions to reprogram the VCM.
  - If the Figure 2 is displayed, the VCM is already the latest calibration. This Service Information does not apply and refer to Workshop Manual for troubleshooting and repair.

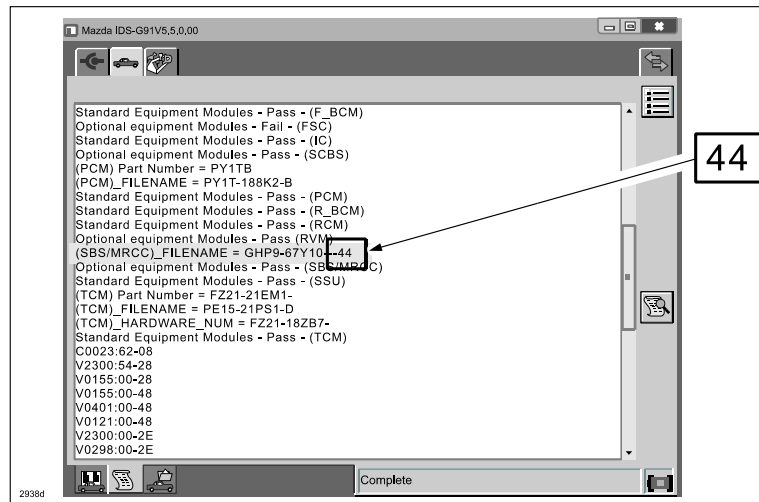
- c. After reprogramming, close the session. Then, open a new session and go to the “Log Viewer” screen. The programmed file name is displayed as shown in figure below. If the last two letters are “44”, the reprogramming has been successfully completed.
