<b>Subject:</b> <b>CREAKING NOISE FROM FRONT LOWER CONTROL ARM BUSHINGS</b>	<b>Bulletin No:</b> 02-005/14
	<b>Last Issued:</b> 12/12/2014

## APPLICABLE MODEL(S)/VINS

2013-2015 Mazda3

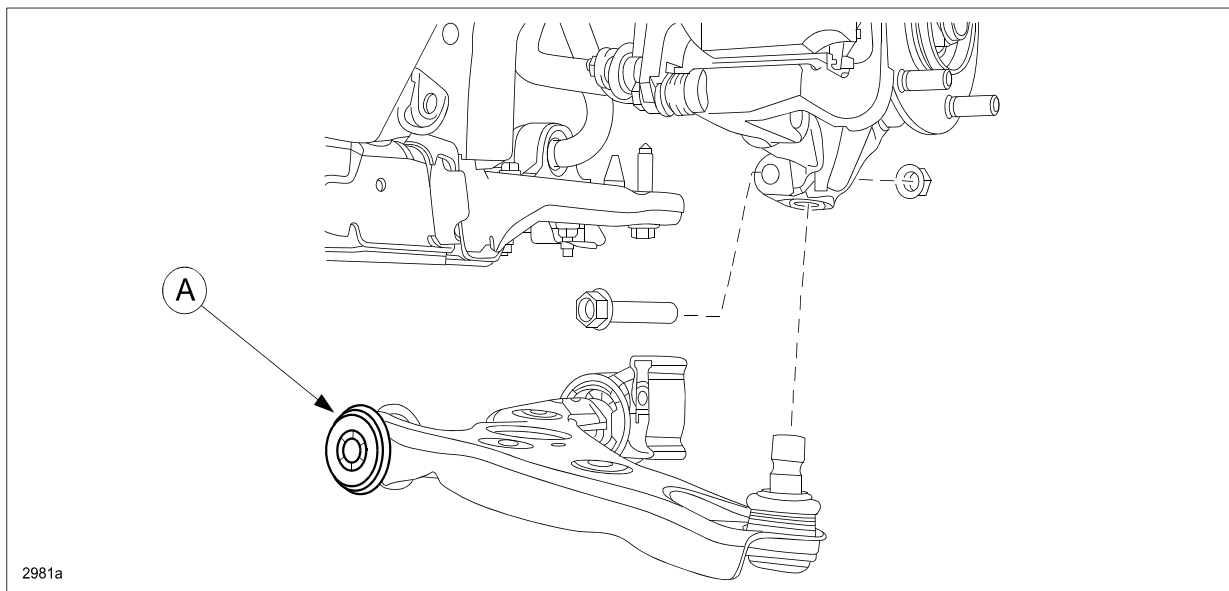
Some vehicles may exhibit a creaking noise from under the front of the vehicle when driving over bumps. The noise occurs at approx. 12 - 25 mph (20 - 40 Km/h) when the road surface is wet or after a car wash. The noise becomes more noticeable when driving over higher bumps.

The creaking noise is caused when the front lower control arm bushing(s) (A) become wet.

Customers having this concern should have their vehicle repaired using the following repair procedure.
