<b>Subject:</b>  SQUEAK NOISE FROM WINDSHIELD WIPER LINK	<b>Bulletin No:</b> 09-050/14
	<b>Last Issued:</b> 12/12/2014

2014-15 Mazda3 vehicles with VINs lower than JM1BM\*\*\*\*\*227327 (produced before August 1, 2014)

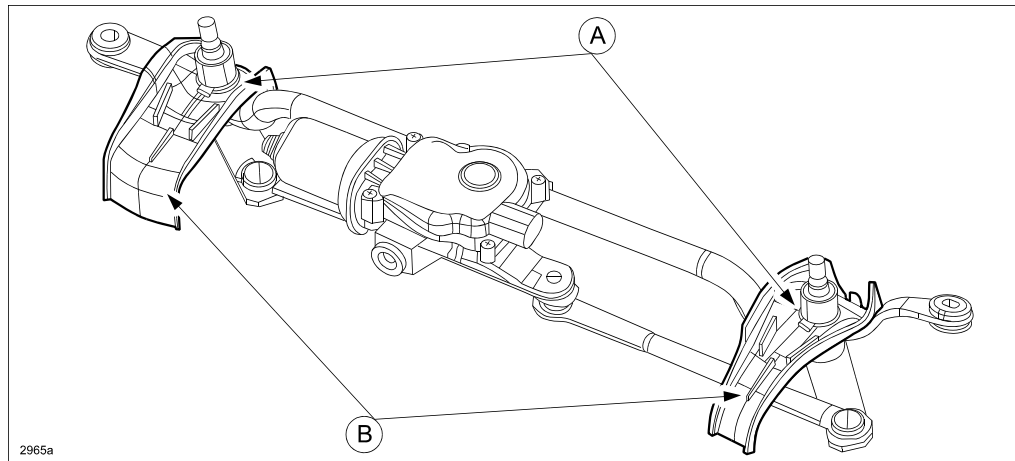
Some vehicles may exhibit a squeaking noise from the windshield wiper link when operating the wipers. This noise may be caused by rust on the sliding parts from water entry through the pivot (A). To prevent water entry, the pivot cover (B) has been enlarged and an O-ring has been added to the pivot.

1. Verify customer concern.
2. If noise occurs when operating the wipers, replace the windshield wiper link assembly with a modified one. Refer to the instructions on MS3 online or the Workshop Manual (section 09-10 WINDSHIELD WIPER MOTOR AND LINK REMOVAL/INSTALLATION).
3. Verify repair.
