TECHNICAL BULLETIN
LTB00582NAS1
27 FEB 2014

Front Overhead Console Lights Turn On / Off Unexpectedly

Range Rover Evoque (LV)

Model Year: 2012-2013

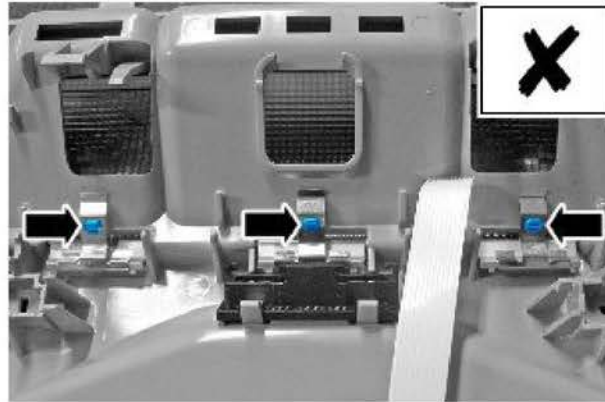
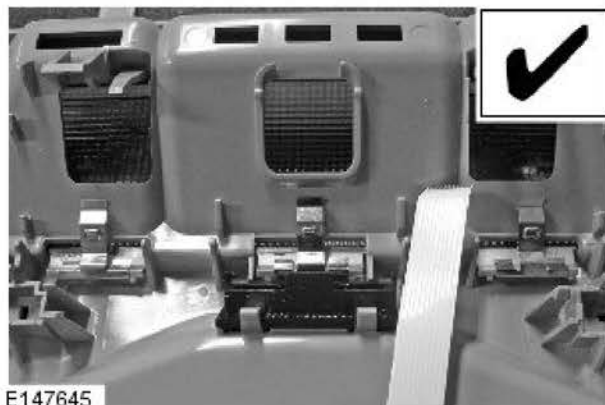
E147645

Cause: This may be caused by fretting corrosion on the contact of the printed circuit board (PCB) in the lamp assembly.

Use the wipe supplied in the kit to make sure all

the grease is removed from the electrical connectors.
