TECHNICAL BULLETIN LTB00596NAS2 04 FEB 2014

Climate Control System Drain Tube Incorrectly Located

Range Rover Sport (LW) Model Year: 2014

Range Rover (LG)

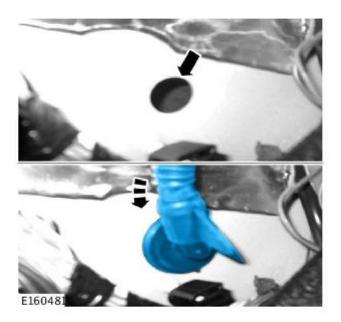
3. Check to see if the Climate Control system drain tube is connected correctly.
