TECHNICAL BULLETIN
LTB00627NAS1
04 FEB 2014

Climate Seats Inoperative

Range Rover Sport (LW)

Model Year: 2014

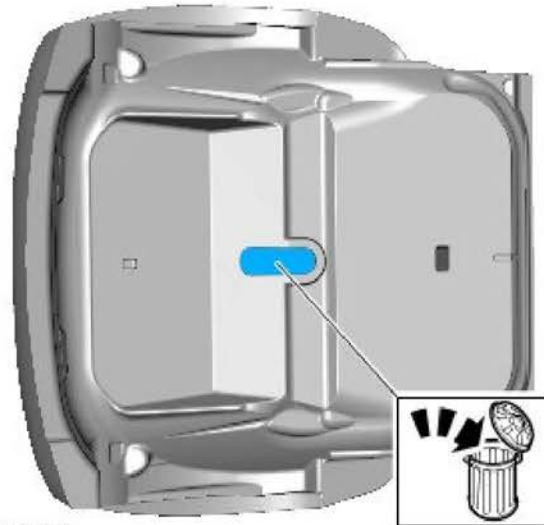
E162589

Cause: This may be caused by the ducting in the seat cushion(s) being blocked by excess foam.

**NOTE: Front seat cushion shown; rear seat similar.**

**NOTE: Rear seat cushion has two holes for ducting; make sure both are clear.**

Inspect all the ducting in the seat base cushion. If the ducting is blocked by excess foam, clear the excess by hand.
