TECHNICAL BULLETIN
LTB00643NAS1
25 FEB 2014

SECTION: 414-01

Battery Charge Warning Lamp On With DTC B11DB-87 Stored

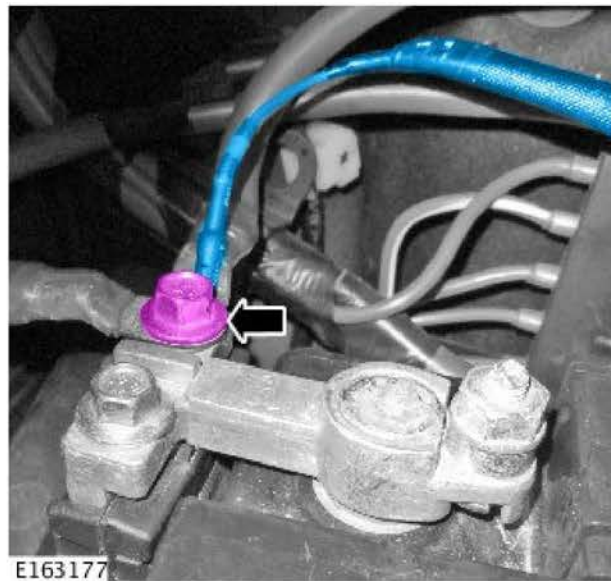
**CAUTION: Make sure that the fused harness is routed in a suitable manner and is not trapped by any components.**

Route the wiring around the rear of the battery; install the BMS fused harness to the positive battery connection.

- Torque: 10 Nm
